# Morton Grove Park District Harrer Park Pool Facility Evaluation

13 July 2017

**Prepared By:**  
Williams Architects Aquatics  
WA Project No. 2017-030

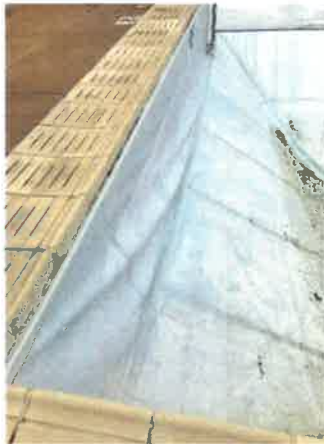
1. The existing PVC pool liner is 19 years old and has exceeded its useful life. It has extensive patching and staff indicated that there are numerous pin holes present. The liner is no longer adhered to the pool walls in the deep well of the pool.

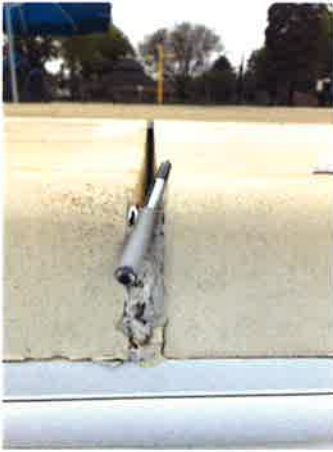
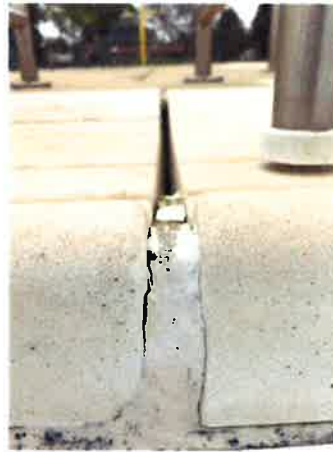
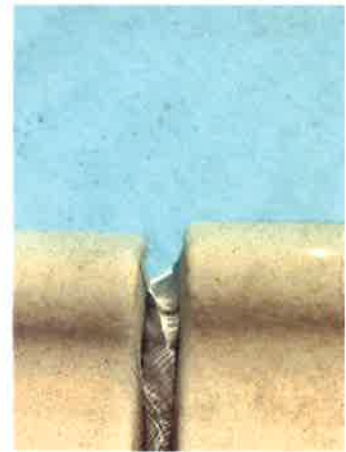
2. The facility has been experiencing major water loss for the past five years. Some piping repairs were made in 2015, which reduced the water loss by approximately 1,000,000 for the season. However, major water loss, 1,364,148 gallons, still continued for the 2016 season. The water loss does not just impact the cost of make-up water but also effects chemical costs and energy costs to heat the water.
3. There is very minimal differential settlement of the perimeter gutter. However, the joints between the coping stones have deteriorated and allow water to flow through the openings, rather than providing uniform perimeter skimming at the hand-hold. This condition effects the surface skimming action and the ability to effectively remove dirt, oils and suspended material.

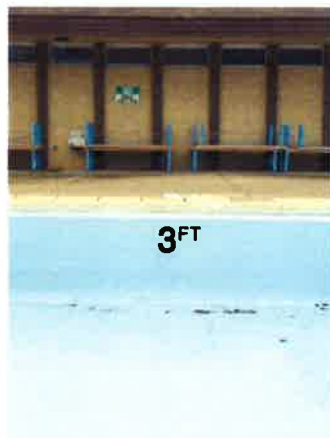
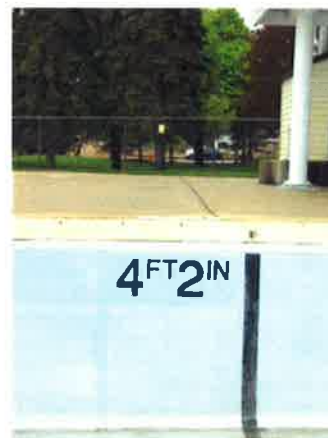
4. There are areas where there are no depth markers on the building or fencing enclosure. *This is a violation of current IDPH code requirements: Section 820.200.i Depth Markers – 1) The water depth shall be marked at or above the water surface on the wall of the pool and on the edge of the deck next to the pool so as to be readable by persons entering or in the pool. Where depth markers cannot be placed on the walls at or above the water level such that at least 50% of the marking is above water level, they shall be placed on the pool wall as high as practicable and also on the fencing or pool enclosure so as to be plainly visible to persons in the pool. Depth markings shall be provided at the shallow and deep ends of the pool, the transition point, and the point of maximum depth, and shall be spaced at not more than 25 foot intervals measured peripherally, except that depth markings are not required at a zero-depth edge.*

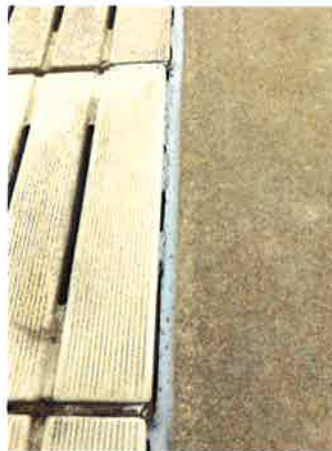
5. There are areas on the pool walls where major cracks can be felt through the liner. In one area where a crack was felt, the upper portion of the pool wall above the crack extended into the pool significantly more than the portion of the pool wall below the crack. This indicates some significant movement and deterioration of the concrete pool structure.
6. A preliminary inspection was performed on the pool walls around the perimeter of the pool, up to the 5'-0" depth, in order to try to locate hollow spots in the concrete structure, which would verify deterioration. It appeared that some hollow spots were present, however it was difficult to identify due to the liner and the fact that in many areas the liner is no longer adhered to the pool walls.
7. The caulk joints behind the coping stones are in fair to poor condition.

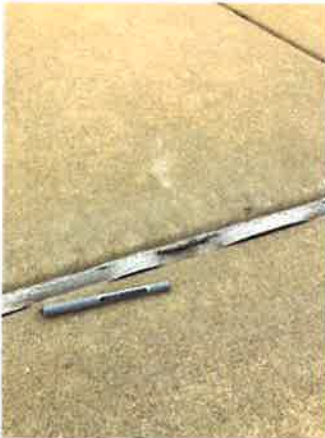
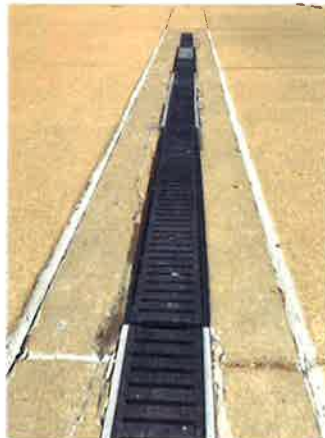
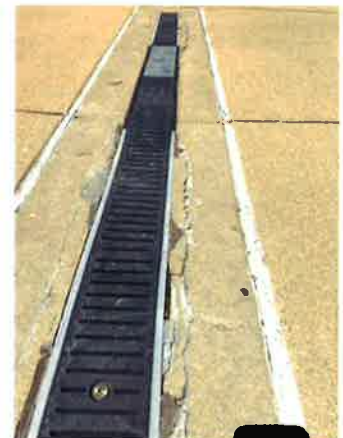
11. The decks are in good condition based on their age. There are a few areas where there is some differential settlement, which creates tripping/toe stubbing hazards for patrons. The concrete around some of the deck drains has deteriorated.

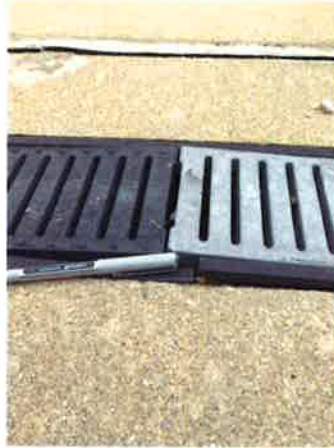
12. A few of the deck drain grates are raised, creating a tripping/toe stubbing hazards for patrons.

<u>RECOMMENDATION</u>	<u>PROBABLE COST RANGE</u>
<b>PRIORITY LEVEL 1</b>	
HIRE A LEAK DETECTION COMPANY TO FIND LOCATION OF POOL LEAKS.	\$4,000 TO \$6,000
REPAIR LEAKS FOUND BY LEAK DETECTION COMPANY. (TO BE VERIFIED UNTIL ACTUAL TEST IS DONE). REPAIR CONCRETE POOL STRUCTURE, PRIOR TO NEW LINER NEW INSTALLATION, AS REQUIRED BY POOL LINER MANUFACTURER INCLUDED.	\$50,000 TO \$75,000
DEMO EXIST, INSTALL NEW PVC POOL LINER	\$100,000 TO \$120,000
REPAIR POOL COPING STONE JOINTS IN THE MAIN POOL AND IN THE WADING POOL. (300 JOINTS TOTAL)	\$35,000 TO \$45,000
INSTALL NEW MAIN DRAIN LINE WITH MODULATING VALVE ON THE WADING POOL. PROVIDE CHEMICAL SAMPLING FEED PUMPS ON EACH MAIN DRAIN TO ALLOW SEPARATE SAMPLING AND CHEMICAL CONTROL OF THE WADING POOL AND THE MAIN POOL	\$70,000 TO \$100,000
INSTALL NEW POOL HEATER (REPLACE EXISTING WITH POSSIBLE UPGRADE)	\$25,000 TO \$50,000
REPLACE SELECTED RAISED DECK DRAIN GRATES	\$1,500 TO \$2,000

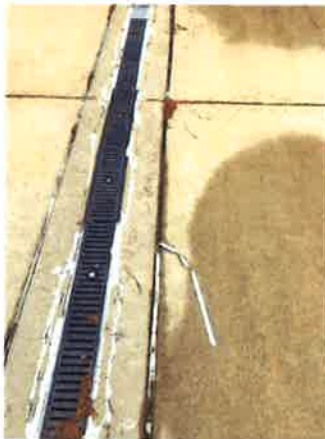
13. There are caulk joints on the concrete decks that are deteriorated and need to be replaced.

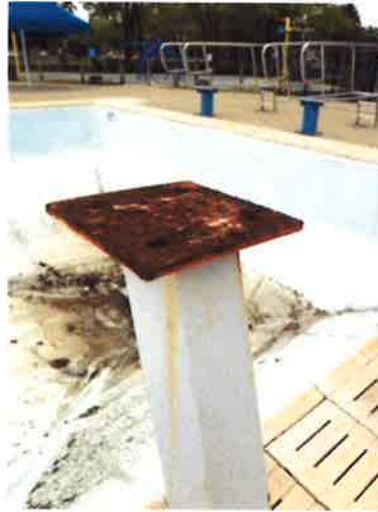
14. The guard chairs have significant corrosion on the top plate of the pedestal, where the platform and chair are attached.

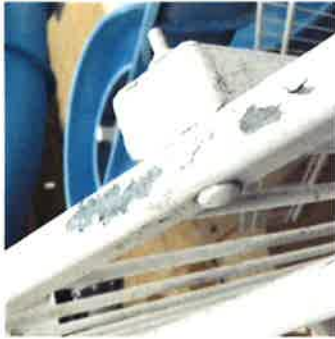
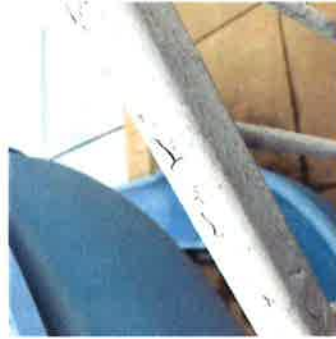
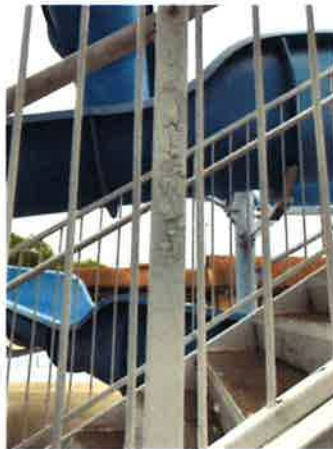
1. The flume slide has had extensive patching and The flume slide finish is very faded.
2. The finish on the flume slide tower and railings is in poor condition. The paint finish is chipping and flaking.

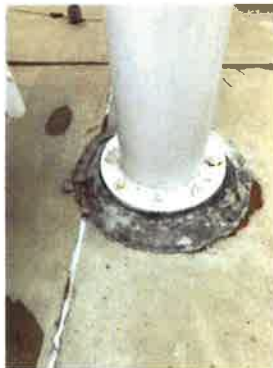
3. The grout under the base plates of the slide columns is severely deteriorated.

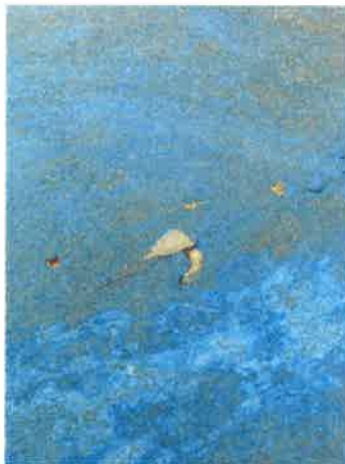
1. Minimal concrete spalling/cracking/surface pop-outs on the concrete surface.

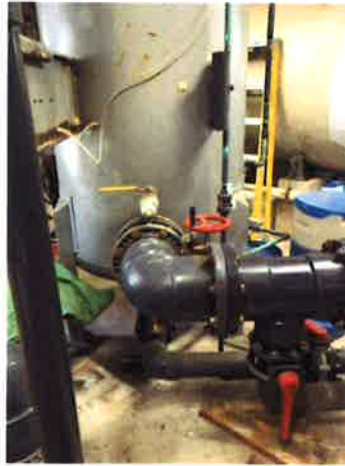
8. The influent pipe going into the filter has an immediate 90 degree elbow right before the flange connection to the filter. This can cause turbulent flow into the filter and

result in DE filter media to fall off the filter elements and pass into the pool. It is recommended that there is a straight length of pipe, a minimum of 5 pipe diameters, before the filter to create a laminar flow.

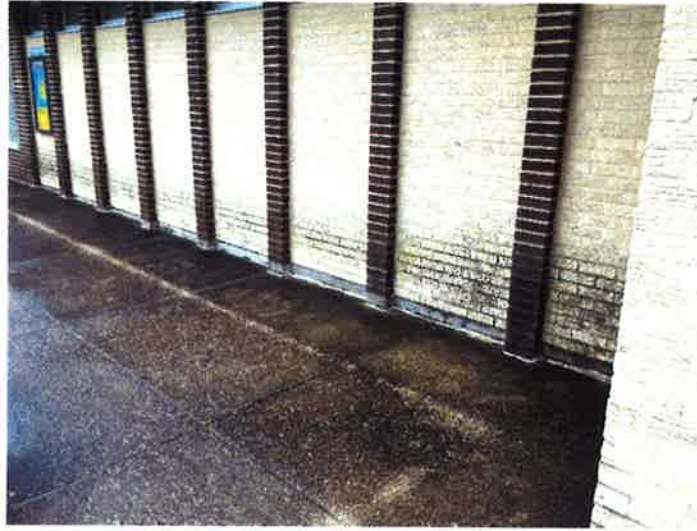
1. Exterior
  - a. Outside pool equipment room south elevation and entire north elevation, moisture has collected on the first several courses of face brick. No weep holes or flashing at the base to allow moisture an outlet is evident.

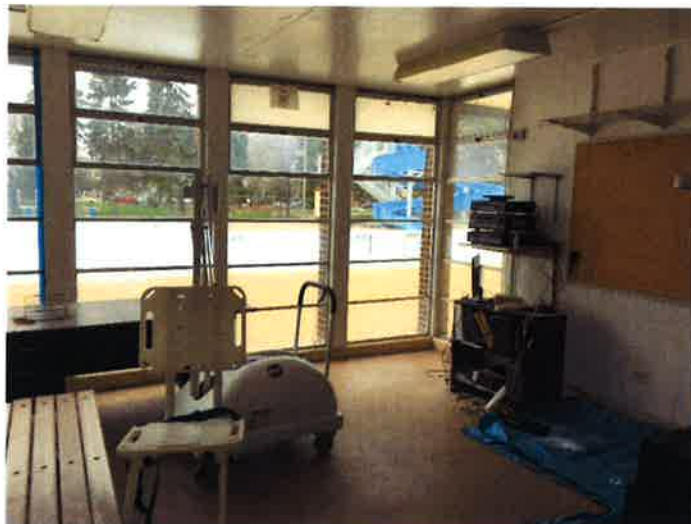
- b. Steel windows has been puttied and sealed. They are showing signs of needing replacement.

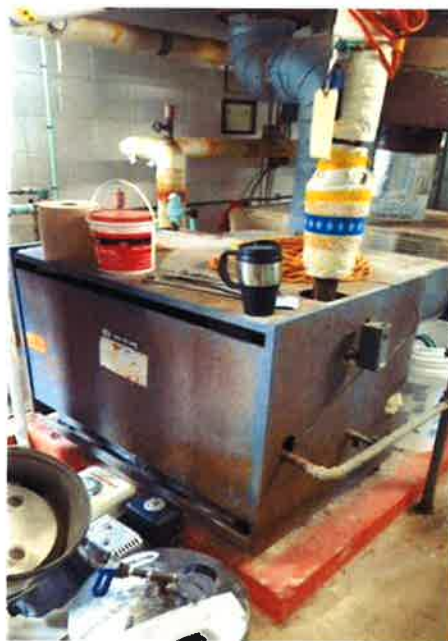
Boiler for radiant floor heat (abandoned)

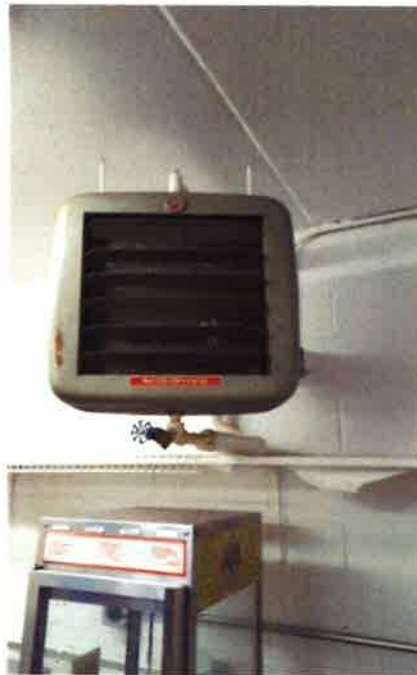
Hot water unit heater in Concessions

The Concession Room was heated by a hot water unit heater however the heater is connected to the abandoned radiant floor heat and is inoperable.
