## Morton Grove Park District Summary

The following comments are a summary of the Morton Grove Park District's accessibility survey. The survey was begun in the summer of 2013. Each park district facility and buildings used for programs were reviewed for their compliance with the new Americans with Disabilities Act Accessibility Guidelines (ADAAG), Illinois Accessibility Codes (IAC), and the proposed Outdoor Developed Standards. In addition, all elements were evaluated using Equivalent Facilitation standards (ADAAG 103) and Dimensional Tolerances (ADAAG 104.1.1).

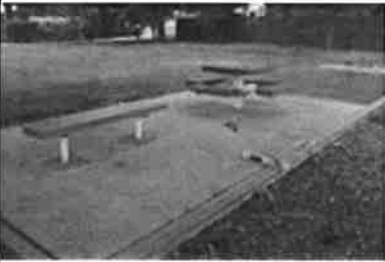
The bench and picnic table area does not provide curb ramp access to the playground surface.	<b>Proposed</b> Outdoor Areas Standards ADAAG 1011	<b>Bench Recommendation:</b> Provide at least 20% but no less than two benches to provide a clear ground space of at least 30" by 48" positioned near the bench with one side adjoining the walkway. The clear ground space should have a slope no steeper than 2% in all directions and should not overlap into the accessible route or another clear ground space. Provide a seat height between 17" AFF minimum to 19" AFF maximum. <b>Option:</b> Consider placing two benches on the playground surface with a companion seating space. <b>UD -</b> Provide benches with armrests, backs and no gaps between the seat and backrest.		Not approved but considered best practices	\$ 1,400.00

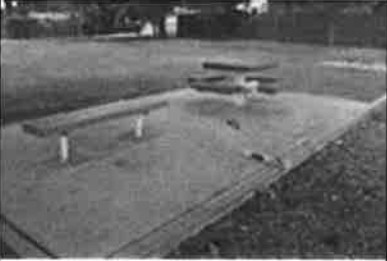
There is only one bench provided.	<u>Proposed</u> Outdoor Areas Standards ADAAG 1011	<b>Bench Recommendation:</b> Provide at least 20% but no less than two benches to provide a clear ground space of at least 30" by 48" positioned near the bench with one side adjoining the walkway. The clear ground space should have a slope no steeper than 2% in all directions and should not overlap into the accessible route or another clear ground space. Provide a seat height between 17" AFF minimum to 19" AFF maximum. <b>Option:</b> Consider placing two benches on the playground surface with a companion seating space. <b>UD -</b> Provide benches with armrests, backs and no gaps between the seat and backrest.	Not approved but considered best practices		\$ 1,400.00

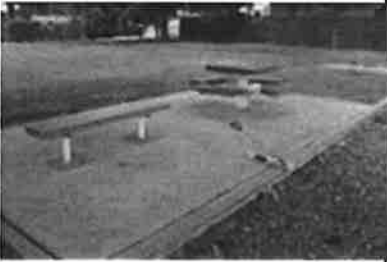
The picnic table provided is not of an accessible design.	<u>Proposed</u> Outdoor Developed Areas Guidelines ADAAG 245 & 1011	<b>Picnic Table Recommendation:</b> At least 20% of picnic tables, but no less than two, be of an accessible design, connected to an accessible route. Relocate or purchase two accessible picnic tables (\$750/each) and locate them on an accessible surface (\$900).	Not approved but considered best practices		\$ 3,300.00

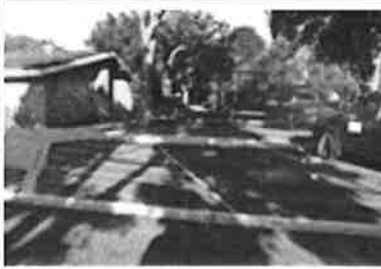
The accessible parking has a running slope of 2.7% to 3.4% in the parking space and access aisle and the cross slope is too steep at 5.9% at the end of the access aisle.	ADAAG 502.4	Regrade the parking spaces on the shortest accessible route to be no steeper than 2% in all directions.	<b>1</b>		\$ 925.00

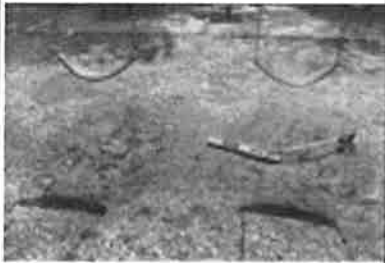
The swing surface slope is too high at 14.6% - 16.9%.	ADAAG 1008.4.2	Provide a regular maintenance to the play surface to provide an accessible route and cross slopes no greater than 2% in all directions for easier transfer to the swing. Provide swings no higher than 24" above the playground surface. An accessible swing with a seat would be recommended at some point. <b>UD</b> - Consider a mat under the swings to prevent a kick-out of the surface material.	2		\$ 100.00

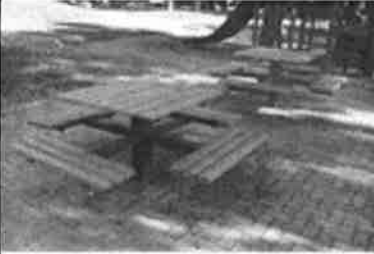
There are two picnic tables provided at the playground but neither one are of an accessible design.	<u>Proposed</u> Outdoor Developed Areas Guidelines ADAAG 245 & 1011	<b>Picnic Table Recommendation:</b> At least 20% of picnic tables, but no less than two, be of an accessible design, connected to an accessible route. Relocate or purchase two accessible picnic tables (\$750/each) and locate them on an accessible surface (\$900).	Not approved but considered best practices		\$ 3,300.00

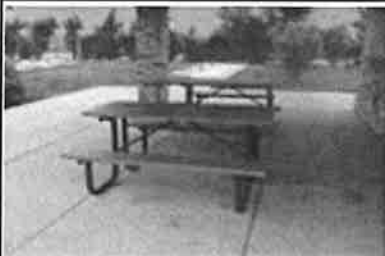
There are two picnic tables provided but only one is of an accessible design.	<b>Proposed</b> Outdoor Developed Areas Guidelines ADAAG 245 & 1011	<b>Picnic Table Recommendation:</b> At least 20% of picnic tables, but no less than two, be of an accessible design, connected to an accessible route. Relocate or purchase one more accessible picnic table (\$750/each) and locate it on an accessible surface (\$900).	Not approved but considered best practices		\$ 1,650.00

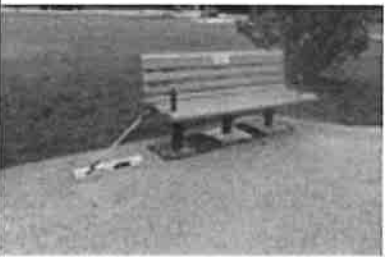
The companion seating provided at the bench has a slope too steep at 3.8%.	<b>Proposed</b> Outdoor Areas Standards ADAAG 1011	<b>Bench Recommendation:</b> Provide at least 20% but no less than two benches to provide a clear ground space of at least 30" by 48" positioned near the bench with one side adjoining the walkway. The clear ground space should have a slope no steeper than 2% in all directions. The clear ground space should not overlap the accessible route or another clear ground space. <b>UD</b> - Provide benches with armrests, backs, seat height between 17" AFF to 19" AFF maximum and no gaps between the seat and backrest.	Not approved but considered best practices		\$ 2,000.00

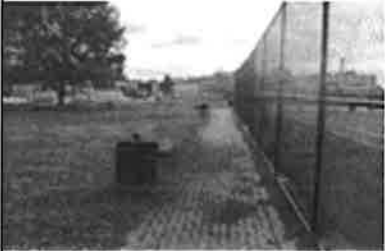
The two benches along the tennis courts do not provide companion seating.	<u>Proposed</u> Outdoor Areas Standards ADAAG 1011	<b>Bench Recommendation:</b> Provide at least 20% but no less than two benches to provide a clear ground space of at least 30" by 48" positioned near the bench with one side adjoining the walkway. The clear ground space should have a slope no steeper than 2% in all directions. The clear ground space should not overlap the accessible route or another clear ground space. <b>UD -</b> Provide benches with armrests, backs, seat height between 17" AFF to 19" AFF maximum and no gaps between the seat and backrest.	Not approved but considered best practices		\$ 2,000.00

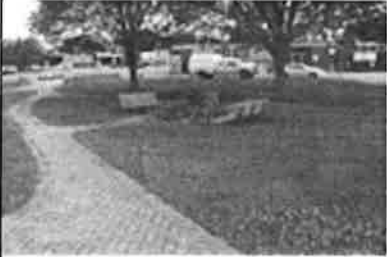
The benches at the planter do not provide companion seating.	<u>Proposed</u> Outdoor Areas Standards ADAAG 1011	<b>Bench Recommendation:</b> Provide at least 20% but no less than two benches to provide a clear ground space of at least 30" by 48" positioned near the bench with one side adjoining the walkway. The clear ground space should have a slope no steeper than 2% in all directions. The clear ground space should not overlap the accessible route or another clear ground space. <b>UD</b> - Provide benches with armrests, backs, seat height between 17" AFF to 19" AFF maximum and no gaps between the seat and backrest.	Not approved but considered best practices		\$ 2,000.00

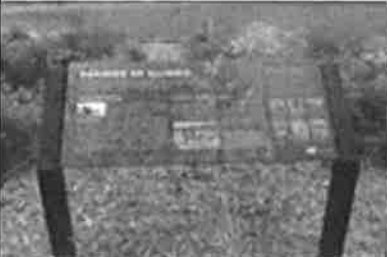
The information sign is not of an accessible design.	Everyone's Welcome: The Americans with Disabilities Act and Museums Accessible Facilities and Exhibits	<b>Signage Recommendation:</b> Provide an accessible typeface such as Helvetica, Arial, Univers or Futura for Sans Serif or New Century Schoolbook, Times Roman or Palatine which is Simple Serif. Provide a type face that is at least 18 points or larger and is provided on a contrasting background of at least 70% and not written over a picture. The signage should be mounted at above the floor at a centerline of 54" AFF. For labels in the display case mount them between 33" to 40" AFF and angle them at a 40 degree to 45 degree angle.	Not required but would be best practices		\$ 160.00

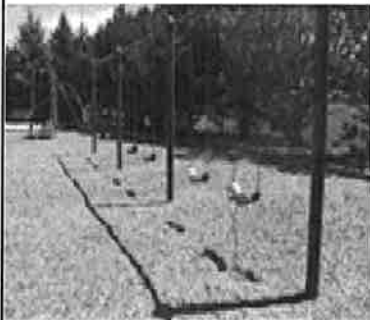
The swing surface has a slope too steep at 12.1% to 21.2% and some swings are too high at 25" to 27 1/2".	ADAAG 1008.4.2	Provide a regular maintenance to the play surface to provide an accessible route and cross slopes no greater than 2% in all directions for easier transfer to the swing. Provide swings no higher than 24" above the playground surface. An accessible swing with a seat would be recommended at some point. <b>UD</b> - Consider a mat under the swings to prevent a kick-out of the surface material.	2		\$ 100.00

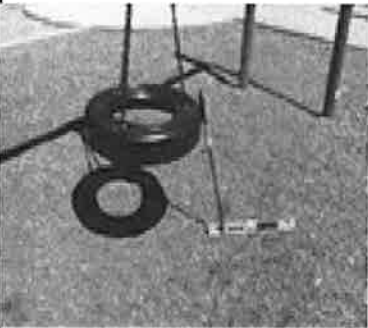
The tire swing has a slope too steep at 19.3% and is mounted too high at 30" AFF.	ADAAG 1008.4.2	Provide a regular maintenance to the play surface to provide an accessible route and cross slopes no greater than 2% in all directions for easier transfer to the tire swing. Maintain the tire swing surface at a height no higher than 24" above the playground surface. <b>UD</b> - Consider a mat under the tire swing to prevent a kick-out of the surface material.	2		\$ 100.00

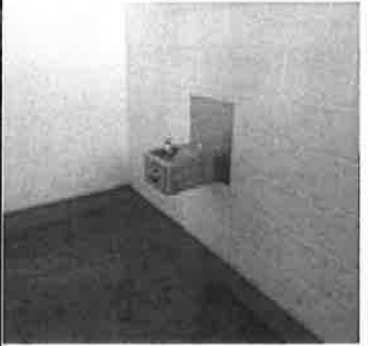
The drinking fountain is not of an accessible design.	ADAAG 211 & ADAAG 602	Provide two individual drinking fountain or a single hi-lo drinking fountain that provides a wheelchair accessible fountain with a spout at 36" maximum and a standing drinking fountain with a height between 38" minimum and 43" maximum. The toe clearance should be a minimum of 9". The water flow should be at least 4" high and located within 5" from the front of the drinking fountain.	4		\$ 4,350.00

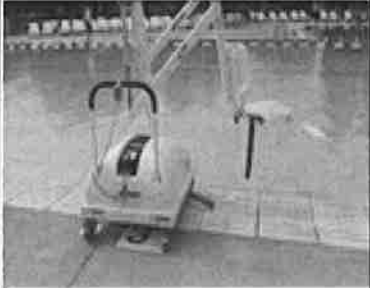
The pool lift provided is not of a permanent design.	ADAAG 1009.2	When replacing, provide a pool lift with that is secured to the pool deck, self operating, have a seat that will locate over the deck, have a 36" wide by 48" deck clearance, a seat height of 16" - 19 " AFF, can lift a minimum of 300 lbs. and submerges in the water at least 18". In the mean time, if this lift can be secured to a life guard stand or similar stationary element, that would be encouraged.	2		NA

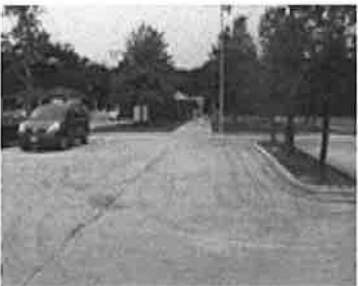
The parking lot has 42 parking spaces with 5 accessible parking spaces noted. Only one has an accessible sign and fine sign the others do not.	IAC 400.310(c)(7)	Because of the size of this parking lot, only one more accessible parking space is required. Additional accessible parking spaces are acceptable to provide greater access. Provide at least one more sign with the International Symbol of Accessibility and a fine sign of a between \$250 and \$350 depending on local codes. Mount the sign at the head of the parking space at 48" minimum from the ground to the bottom of the sign.	1		\$ 275.00

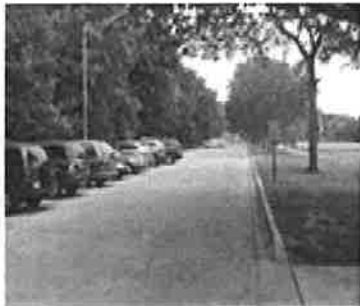
The parking lot on the west side of the pool has 75 parking spaces but only one is marked accessible.	IAC 400.310(c)	Provide two more accessible parking spaces with an access aisle a minimum of 96" plus a sign with the International Symbol of Accessibility and a fine sign of \$250 to \$350 (Depending on local code) at the head of the parking space. The parking spaces and access aisles should be no steeper than 2% in all directions and on a firm and stable surface. Locate the accessible parking space on the shortest accessible route. <b>UD</b> - Provide a Universally Designed parking space with a minimum 11' (132") parking space and a minimum 5' (60") access aisle. Consider placing an accessible parking space near the ballfields.	1		\$ 1,550.00

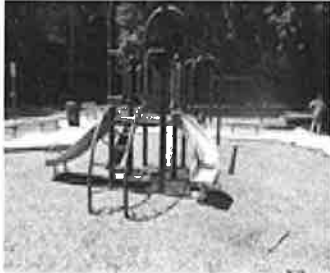
There is no transfer platform or ramp provided on the playground equipment.	ADAAG 1008.3.1.2	Provide a surface at the transfer platform that is between 11" and 18" above the ground. Because of the age and design of this playground, a new transfer platform may not be able to added. If so, consideration should be made to replace this playground.	2		\$ 1,785.00

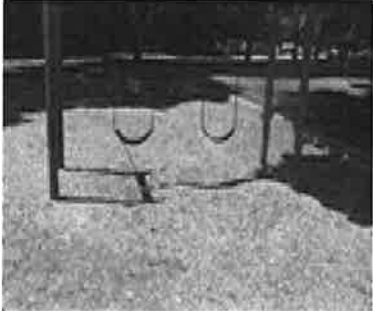
The swing surface slope is too high at 10.6% - 15.2%.	ADAAG 1008.4.2	Provide a regular maintenance to the play surface to provide an accessible route and cross slopes no greater than 2% in all directions for easier transfer to the swing. Provide swings no higher than 24" above the playground surface. An accessible swing with a seat would be recommended at some point. <b>UD</b> - Consider a mat under the swings to prevent a kick-out of the surface material.	2		\$ 100.00

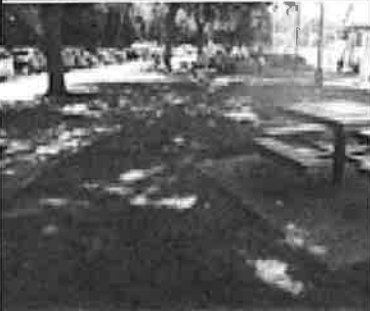
The walkway between the picnic tables is broken and uneven for 41'.	ADAAG 403.1	Remove and replace this walkway and provide a surface that is firm and stable with a running slope no steeper than 5% and a cross slope not steeper than 2%, a minimum clear width of 36" and gaps no wider than 1/2" and no deeper than 1/2".	1		\$ 2,500.00

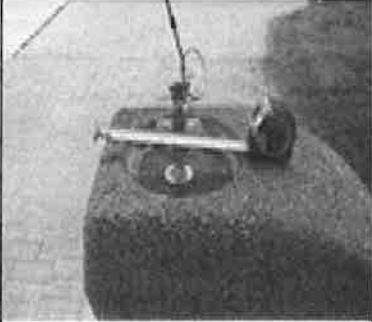
The drinking fountain at field #2 has a spout too far back at 6 1/4".	ADAAG 211 & ADAAG 602	Provide two individual drinking fountain or a single hi-lo drinking fountain that provides a wheelchair accessible fountain with a spout at 36" maximum and a standing drinking fountain with a height between 38" minimum and 43" maximum. The toe clearance should be a minimum of 9". The water flow should be at least 4" high and located within 5" from the front of the drinking fountain.	4		\$ 4,350.00

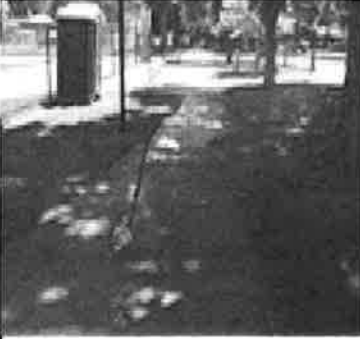
The walkway between the museum annex and ballfield #5 has a cross slope too steep at 2.6% - 3.4% for 46' and has some low spots that have collected mud and water.	ADAAG 403.3	Attempt a "mud jacking" technique or remove and regrade section to provide a cross slope no greater than 2% and raise the low areas so water and mud do not collect.	1		\$ 1,575.00

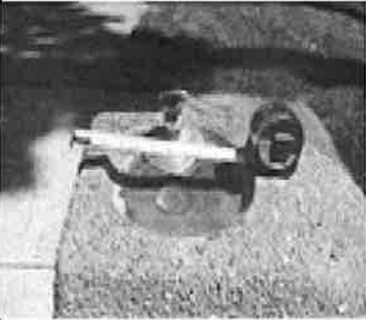
The drinking fountain at field #5 has a spout too far back at 6 1/4" from the front of the drinking fountain.	ADAAG 211 & ADAAG 602	Provide two individual drinking fountain or a single hi-lo drinking fountain that provides a wheelchair accessible fountain with a spout at 36" maximum and a standing drinking fountain with a height between 38" minimum and 43" maximum. The toe clearance should be a minimum of 9". The water flow should be at least 4" high and located within 5" from the front of the drinking fountain.	4		\$ 4,350.00

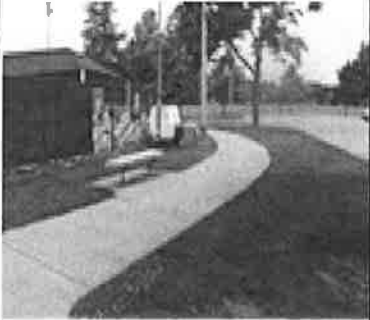
The two benches at the splash pad do not provide companion seating.	<u>Proposed</u> Outdoor Areas Standards ADAAG 1011	<b>Bench Recommendation:</b> Provide at least 20% but no less than two benches to provide a clear ground space of at least 30" by 48" positioned near the bench with one side adjoining the walkway. The clear ground space should have a slope no steeper than 2% in all directions. The clear ground space should not overlap the accessible route or another clear ground space. <b>UD -</b> Provide benches with armrests, backs, seat height between 17" AFF to 19" AFF maximum and no gaps between the seat and backrest.	Not approved but considered best practices		\$ 560.00		
<b>Estimated Total Cost for Outdoor Accessibility Upgrades for Harrer Park and</b>						<b>\$ 8,860.00</b>

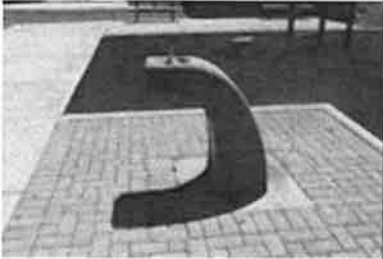
The drinking fountain provided is not of an accessible design.	ADAAG 211 & ADAAG 602	Provide two individual drinking fountain or a single hi-lo drinking fountain that provides a wheelchair accessible fountain with a spout at 36" maximum and a standing drinking fountain with a height between 38" minimum and 43" maximum. The toe clearance should be a minimum of 9". The water flow should be at least 4" high and located within 5" from the front of the drinking fountain.	4		\$ 4,350.00

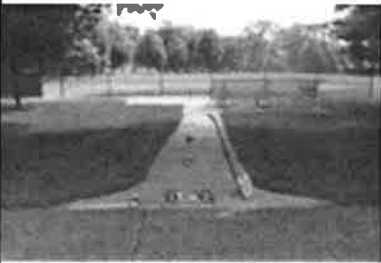
The walkway to Field #1 north bleacher has a running slope too steep at 5.6% - 8.0% for 9'.	ADAAG 403.3	Remove and regrade section to provide an accessible route with a running slope no greater than 5% and an cross slope no greater than 2% for 15'. <b>Option:</b> Since this area is equal to a ramp slope, adding only handrails on both sides would be acceptable. See ADAAG 405.8.	1		\$ 925.00

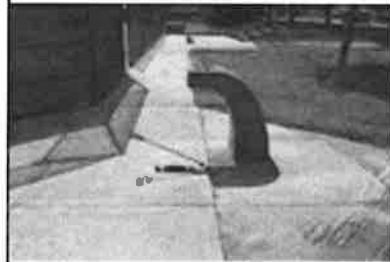
The drinking fountain is only a wheelchair design.	ADAAG 211 & ADAAG 602	Provide another individual drinking fountain at a standing height or a single hi-lo drinking fountain that provides a wheelchair accessible fountain with a spout at 36" maximum and a standing drinking fountain with a height between 38" minimum and 43" maximum. The toe clearance should be a minimum of 9".	4		\$ 2,125.00

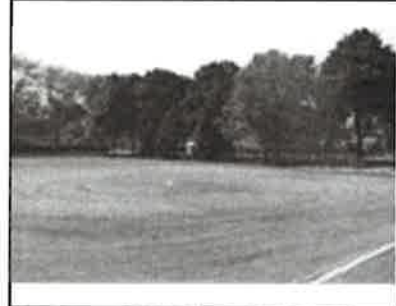
The portable toilet provided is not on an accessible route for 62'.	ADAAG 213.2	For portable toilets, provide at least 5% but no less than one be of an accessible portable toilet design on an accessible route and designed with the International Symbol of Accessibility. When the company delivers a portable toilet make sure they locate them on an accessible route.

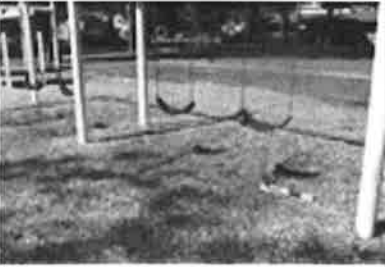
The swing surface slope is too high at 17.2% - 23.8%.	ADAAG 1008.4.2	Provide a regular maintenance to the play surface to provide an accessible route and cross slopes no greater than 2% in all directions for easier transfer to the swing. Provide swings no higher than 24" above the playground surface. An accessible swing with a seat would be recommended at some point. <b>UD</b> - Consider a mat under the swings to prevent a kick-out of the surface material.	2		\$ 100.00

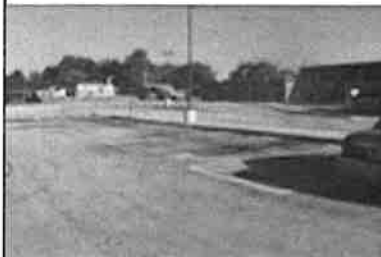
The parking lot has 4 accessible parking spaces and 51 total spaces. Only 3 accessible parking spaces are required. There parking spaces have running slopes too steep at 2.9% to 3.5%. The two middle spaces are OK from a slope perspective but do not provide signage.	IAC 400.310(c)(7)	Provide a sign with the International Symbol of Accessibility and a fine sign of a between \$250 and \$350 depending on local codes. Mount the sign at the head of the parking space at 48" minimum from the ground to the bottom of the sign. Provide these at the two middle parking spaces nearer to the curb ramp.	1		\$ 550.00

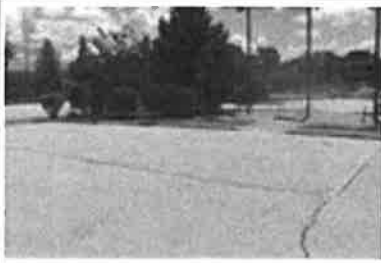
There is no sign provided for the accessible parking.	IAC 400.310(c)(7)	Provide a sign with the International Symbol of Accessibility and a fine sign of a between \$250 and \$350 depending on local codes. Mount the sign at the head of the parking space at 48" minimum from the ground to the bottom of the sign.	1		\$ 275.00

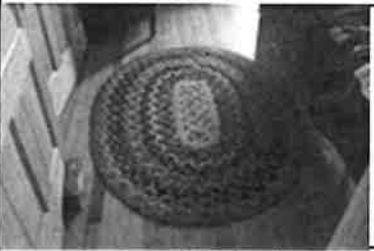
The museum has loose rugs that are located throughout the house but are not attaches and could be a tripping hazard for people.	ADAAG 302.2	If these are not historic, then provide a rug with a heavier backing or tape the mat to the floor. If these are historic, place in locations to limit people walking on them.	1		\$ 150.00

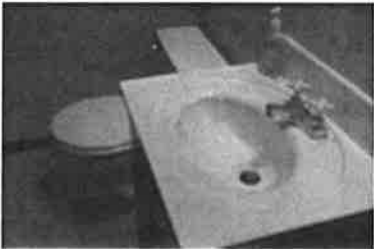
The toilet does not provide grab bars.	ADAAG 604.5	Provide a rear grab bar a minimum of 36" long mounted 12" from the centerline of the toilet to the corner and 24" from the centerline to the open side of the toilet. Also, provide a side grab bar a minimum of 42" long and a maximum of 12" from the corner. Both grab bars should be mounted at 33" to 36" to the top of the grab bar.	<b>3</b>		\$ 525.00

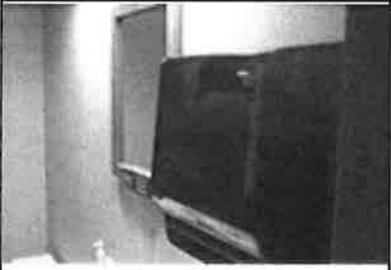
The mirror is mounted too high at 50 1/2" to the reflective surface.	ADAAG 603.3	Lower the mirror above the sink or countertop to be no higher than 40" to the reflective surface. Mirrors not mounted above the sink or a counter top should be mounted no higher than 35" to the reflective surface. <b>UD</b> - A full-length mirror would be a recommended option.	4		\$ 460.00

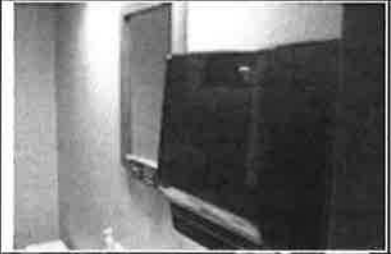
The paper towel dispenser is mounted to 62" AFF to the handle.	ADAAG 308	Remount the paper towel dispenser to provide a reach range no higher than 48" AFF for a forward reach over an obstruction no deeper than 20" or a side reach of 48" AFF over an object no deeper than 10".	3		\$ 100.00

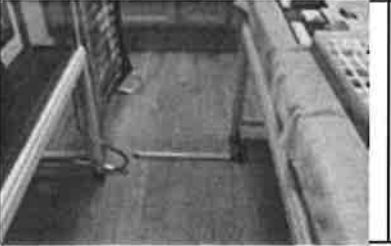
Some areas have pinch points that could be a tripping hazard for people.	ADAAG 403.5.1	Move displays and elements to provide a clear accessible route that is 36" wide but can narrow down to 32" but for no more that 24".	1		\$ 100.00

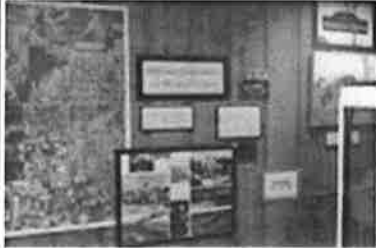
The signage and labels on the wall varies from 26 1/2" to 92" AFF.	Everyone's Welcome: The Americans with Disabilities Act and Museums Accessible Facilities and Exhibits	<b>Signage Recommendation:</b> Provide an accessible typeface such as Helvetica, Arial, Univers or Futura for Sans Serif or New Century Schoolbook, Times Roman or Palatine which is Simple Serif. Provide a type face that is at least 18 points or larger and is provided on a contrasting background of at least 70% and not written over a picture. The signage should be mounted above the floor at a range of 54" to 66" to the centerline of the sign. The height of 54" centerline to a label is consider optimum viewing height	Not required but would be best practices		\$ 500.00

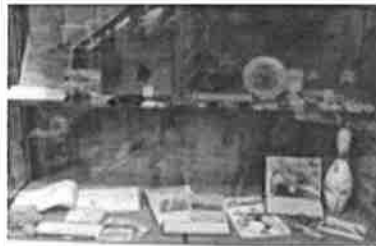
Several of the labels are on tables or in cases and lying flat and at varying heights.	Everyone's Welcome: The Americans with Disabilities Act and Museums Accessible Facilities and Exhibits	<b>Signage Recommendation:</b> Provide an accessible typeface such as Helvetica, Arial, Univers or Futura for Sans Serif or New Century Schoolbook, Times Roman or Palatine which is Simple Serif. Provide a type face that is at least 18 points or larger and is provided on a contrasting background of at least 70% and not written over a picture. For labels in the display case or on tables mount them between 33" to 40" AFF and angle them at a 40 degree to 45 degree angle.	Not required but would be best practices		\$ 500.00

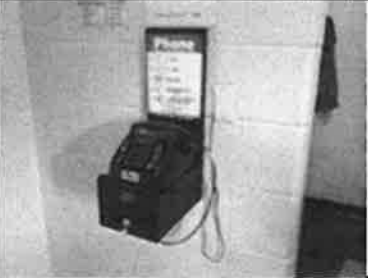
The telephone is mounted at 37 1/2" AFF and protrudes 11".	ADAAG 307	Provide a cane detectable barrier below 27" and the width of the telephone.	<b>1</b>		\$ 100.00

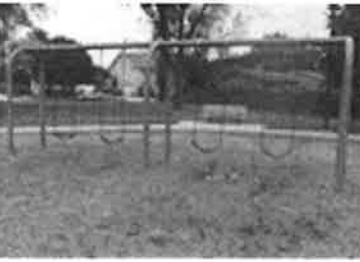
The swing surface slope is too high at 16.2% - 22.2%.	ADAAG 1008.4.2	Provide a regular maintenance to the play surface to provide an accessible route and cross slopes no greater than 2% in all directions for easier transfer to the swing. Provide swings no higher than 24" above the playground surface. An accessible swing with a seat would be recommended at some point. <b>UD</b> - Consider a mat under the swings to prevent a kick-out of the surface material.	2		\$ 100.00

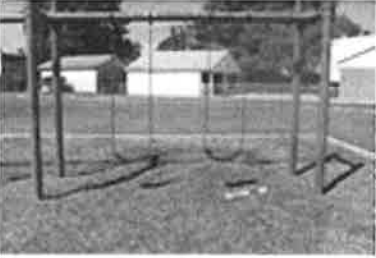
The swing surface slope is too high at 20.9% - 25.3%.	ADAAG 1008.4.2	Provide a regular maintenance to the play surface to provide an accessible route and cross slopes no greater than 2% in all directions for easier transfer to the swing. Provide swings no higher than 24" above the playground surface. An accessible swing with a seat would be recommended at some point. <b>UD</b> - Consider a mat under the swings to prevent a kick-out of the surface material.	2		\$ 100.00

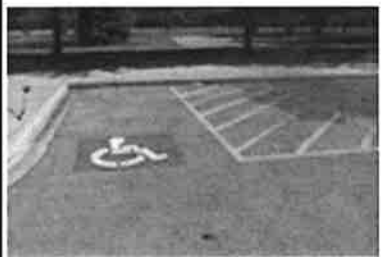
The accessible parking space in the east parking lot does not have a sign or fine sign.	IAC 400.310(c)(7)	Provide a sign with the International Symbol of Accessibility and a fine sign of a between \$250 and \$350 depending on local codes. Mount the sign at the head of the parking space at 48" minimum from the ground to the bottom of the sign.	1		\$ 275.00

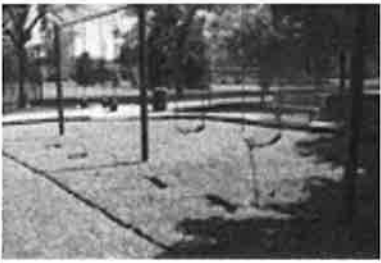
The swings have a surface slope too high at 12.7% - 20.5%.	ADAAG 1008.4.2	Provide a regular maintenance to the play surface to provide an accessible route and cross slopes no greater than 2% in all directions for easier transfer to the swing. Provide swings no higher than 24" above the playground surface. An accessible swing with a seat would be recommended at some point. <b>UD</b> - Consider a mat under the swings to prevent a kick-out of the surface material.	2		\$ 100.00

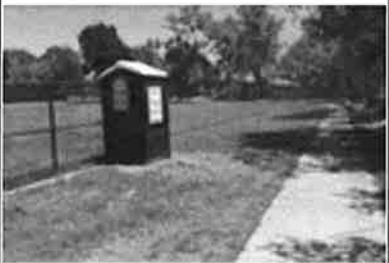
The portable toilet provided is not of an accessible design and is not on an accessible route.	ADAAG 213.2	For portable toilets, provide at least 5% but no less than one be of an accessible portable toilet design on an accessible route and designed with the International Symbol of Accessibility. When the company delivers a portable toilet make sure they locate them on an accessible route.	3		N/A

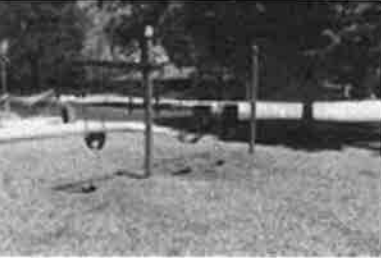
The swings surface slope is too high at 17.9% - 18.4%.	ADAAG 1008.4.2	Provide a regular maintenance to the play surface to provide an accessible route and cross slopes no greater than 2% in all directions for easier transfer to the swing. Provide swings no higher than 24" above the playground surface. An accessible swing with a seat would be recommended at some point. <b>UD</b> - Consider a mat under the swings to prevent a kick-out of the surface material.	2		\$ 100.00

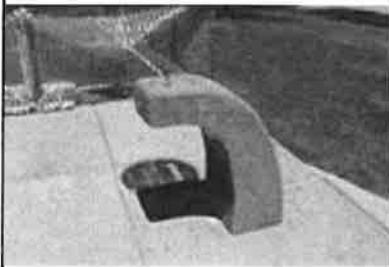
The drinking fountain has a spout too far back at 7".	ADAAG 211 & ADAAG 602	Provide two individual drinking fountain or a single hi-lo drinking fountain that provides a wheelchair accessible fountain with a spout at 36" maximum and a standing drinking fountain with a height between 38" minimum and 43" maximum. The toe clearance should be a minimum of 9". The water flow should be at least 4" high and located within 5" from the front of the drinking fountain.	<b>4</b>		\$ 4,350.00

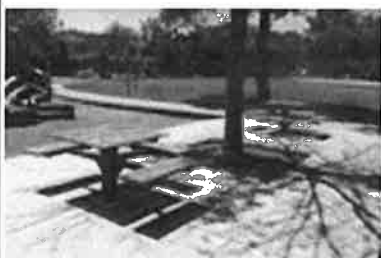
There are two picnic tables provided but the one where the section was removed is not accessible design because of knee clearance too low at 25 1/2" AFF.	<b>Proposed</b> Outdoor Developed Areas Guidelines ADAAG 245 & 1011	<b>Picnic Table Recommendation:</b> At least 20% of picnic tables, but no less than two, be of an accessible design, connected to an accessible route. Relocate or purchase two accessible picnic tables (\$750/each) and locate them on an accessible surface (\$900).		Not approved but considered best practices	\$ 3,300.00

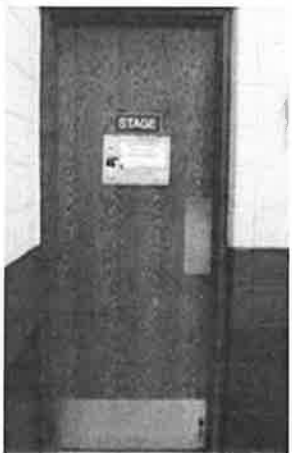
The north door to the gym has an opening force too high at 10 lbs. and closes too quickly at 4 seconds	ADAAG 404.2.8 & ADAAG 404.2.9	Adjust the closer so the door opening force is no heavier than 5 lbs. to open and takes a minimum of 5 seconds to close or provide an automatic door opener at the door.	2		\$ 100.00		
	The south door to the gym has an opening force too high at 12 lbs. and closes too quickly at 4 seconds	ADAAG 404.2.8 & ADAAG 404.2.9	Adjust the closer so the door opening force is no heavier than 5 lbs. to open and takes a minimum of 5 seconds to close or provide an automatic door opener at the door.	2		\$ 100.00
