# Morton Grove Park District Harrer Park Pool Facility Evaluation

13 July 2017

**Prepared By:**  
Williams Architects Aquatics  
WA Project No. 2017-030

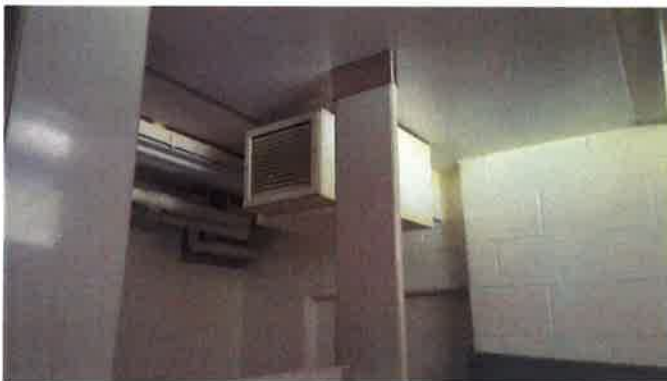
Exposed exhaust ductwork in Bathhouse

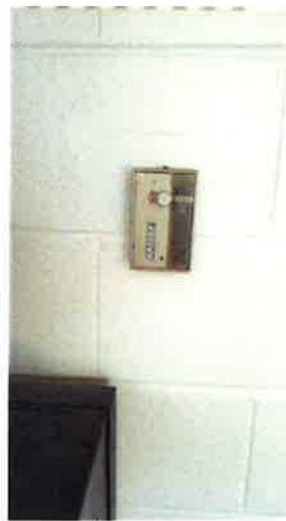
The Concession Room was heated by a hot water unit heater however the heater is connected to the abandoned radiant floor heat and is inoperable.

Thermostat for radiant floor heat

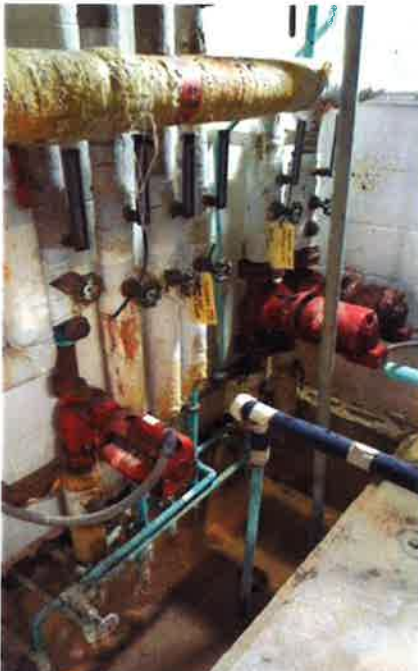
Zone pumps for radiant floor heat

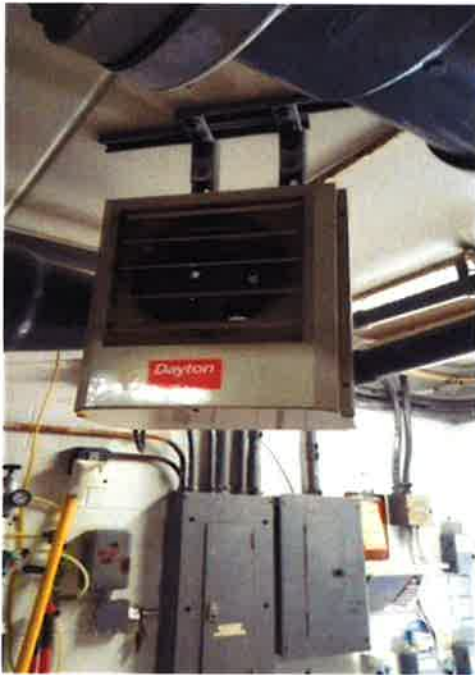
The Pool Filter Room is heated by an electric unit heater controlled by a wall mounted thermostat. The chemical storage room has an inline exhaust fan with intake ductwork routed to floor level and discharge ductwork to a wall louver.

Electric unit heater in boiler room

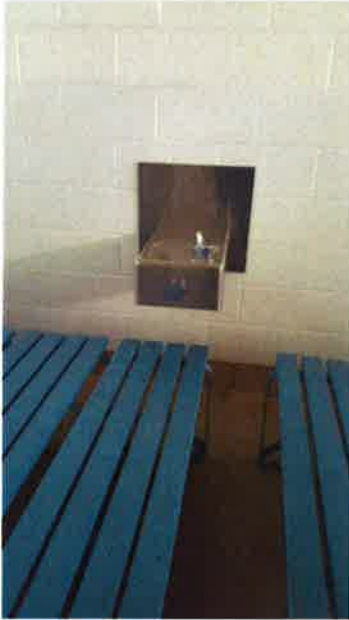
Drinking fountain

Women's Dressing Room, this room consists of (1) one drinking fountain.

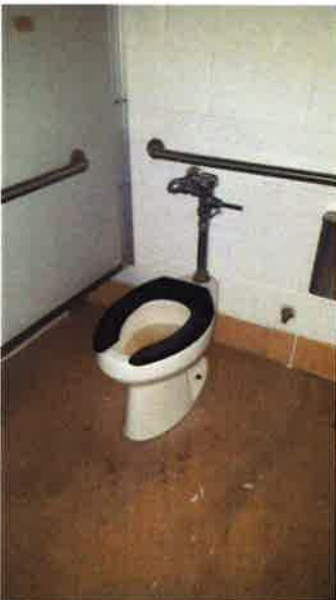
Water closet and hose bibb

Women' Dry Toilet Room, this room consists of (2) two floor set manual flush valve water closet, (2) two wall hung lavatories with single handle metering faucets, (2) two hose bib's and (1) one floor drain.

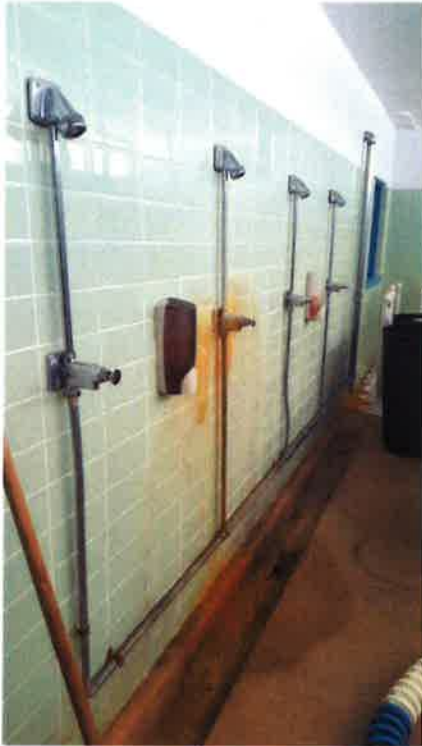
Showers

Women's Shower, this room consists of (9) nine surface mounted metering shower faucets, Floor trenches with drains and area drains.

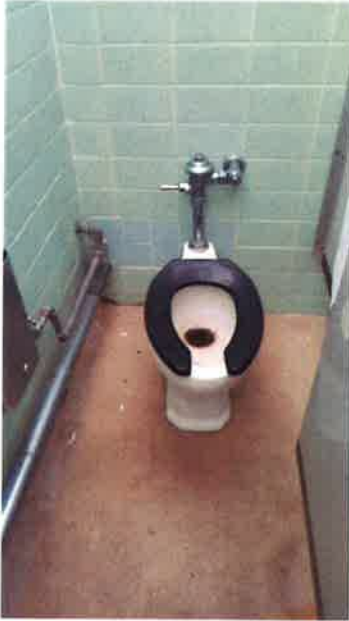
Water closet

Women's Wet Toilet, this room consists of (4) four floor set manual flush valve water closets, (1) one floor drain and (1) one hose bib.

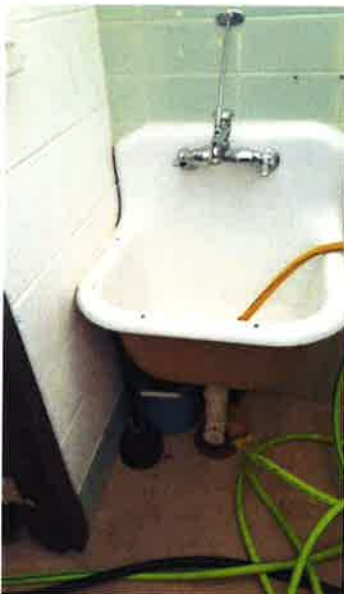
Service sink

Women's Janitor / Storage, this room consists of (1) one service sink

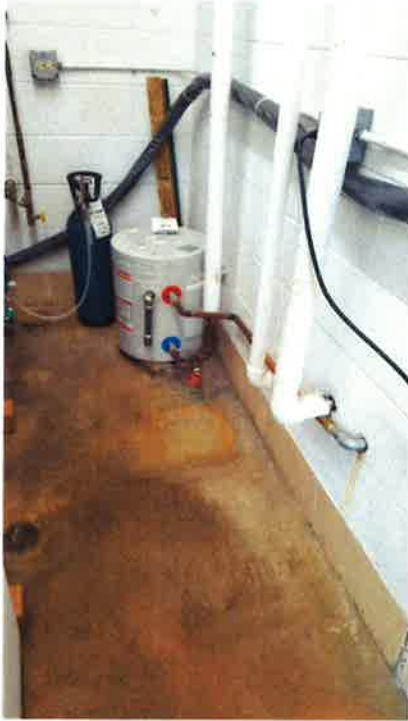
Water heater

Concessions, this room consists of (1) one electric water heater, (1) one floor drain, (1) one hose bib, (1) one three compartment sink, (1) one grease trap and 91) one hand sink.

The system appears to be working properly and in poor condition.  
Water piping appears to be mostly original and in poor condition.  
Fixtures and equipment appear to be mostly original and in poor condition.

Correct code violations.  
Remove and replace the water piping system.  
Remove and replace all fixtures.  
Remove and replace the water heating system. Remove and replace existing thermostatic mixing valve.

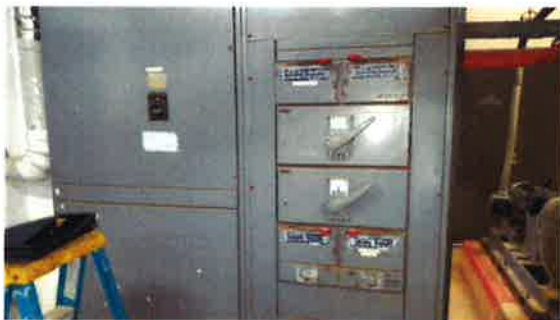
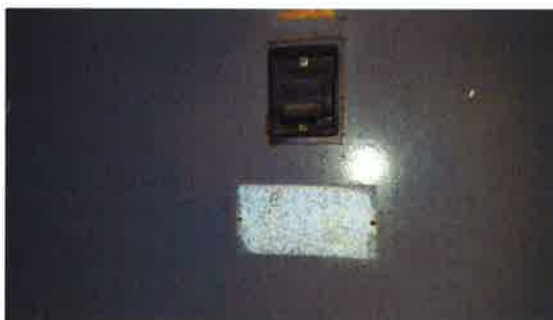
1. Panel LP-2 is a 225 amp 120/208V 3PH, 4W 36-circuit main lug only panel.
2. Panel PP is a 100 amp 120/208V 3PH, 4W 30-circuit main lug only panel.
3. Concession panel is rated 200 amps 120/208V 3PH, 4W 24-circuit main lug only and is fed with a 100 amp feed and disconnect switch.
4. There is a panel tagged Harrer Guard Rm. and appears to be a 200 amp 120/208V 3PH, 4W 42-circuit main lug only panel.
5. There is a panel located in the pool equipment room also tagged as Harrer Guard Rm. and it is a 200 amp 120/208V 3PH, 4W 42-circuit main lug only panel and appears to be fed with a 200 amps feed and disconnect switch.
6. There is a 480V panel and a 45KVA 480-120/208V 3Ph, 4W transformer present in the pool equipment room. This equipment currently appears to be abandoned.

The existing exterior meter socket is in poor condition. The main switchboard is showing signs of rusting and corrosion with some of the disconnect switches not identified as to what they serve. Panels LP-2 and the Concession panel are in good condition. Panel PP interior is in good condition with the cover rusting and in poor condition. The 200 amp 120/208V 3PH, 4W 42-circuit main lug only panel tagged Harrer Guard Rm. is rusting and in poor condition. The panel located in the pool equipment room also tagged as Harrer Guard Rm. is badly rusted and in poor condition. The 480V panel and a 45KVA 480-120/208V 3Ph, 4W transformer present in the pool equipment room are showing signs of rust and are average to poor condition.

Replace the existing main electrical service switchboard, meter and panels that are rusted and corroded. Utilize Nema 4X enclosures within the Pool Equipment Room.

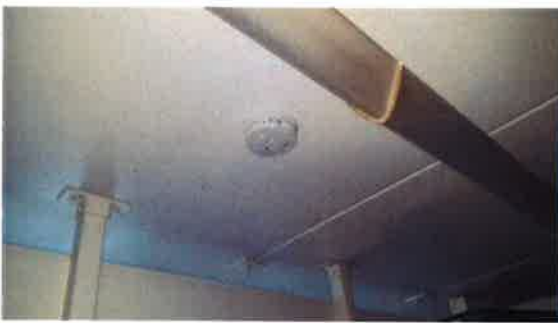
Interior lighting consists of combination of T-5 lamped linear industrial, wraparound, and vapor-tight surface mounted fluorescent fixtures, surface mounted sockets with screw-in compact fluorescent lamps and surface mounted 1' x 1' square vapor-tight fixtures.

The existing interior lighting fixtures range from average, newer vapor-tight fixtures to poor condition, older lensed wraparound and industrial fixtures with some having missing, broken, or cracked lenses. The 1' x 1' square vapor-tight fixtures look to be in good condition. The combination exit sign and emergency light fixture is in good condition.

Replace existing interior lighting fixtures that are in poor condition with new LED type lighting fixtures.

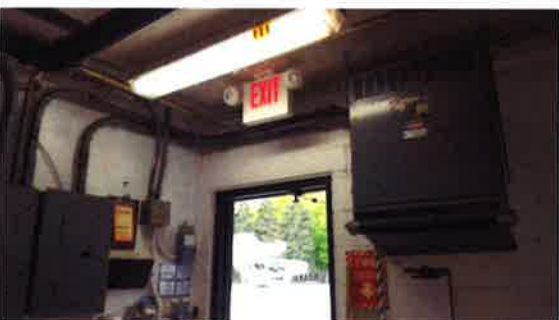
There is only one exit sign and an emergency battery light present in the pool equipment room. The balance of the building does not have powered exit signs with emergency battery back-up or emergency battery lighting units.

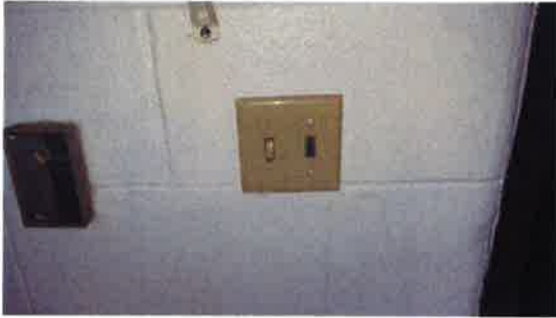
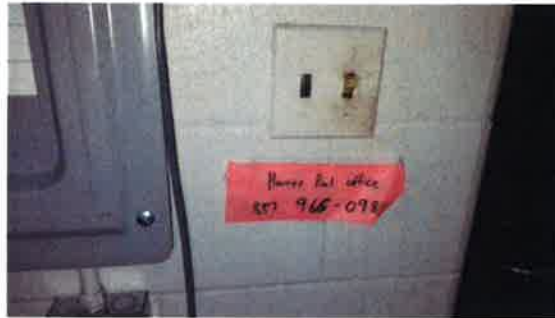
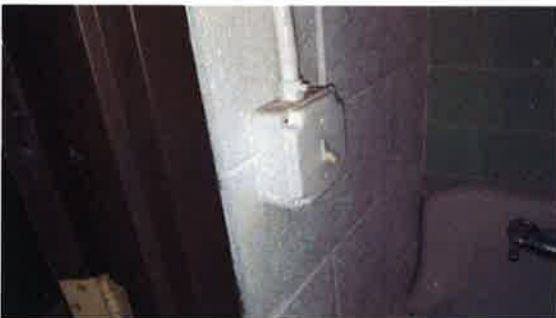
Interior lighting controls consist of local toggle and key operated switches.

Lighting control switches are in average to poor condition with some faceplates showing dirt.

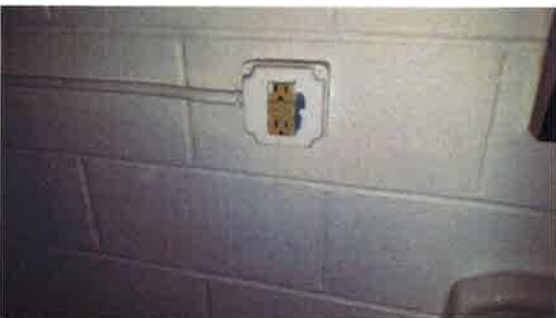
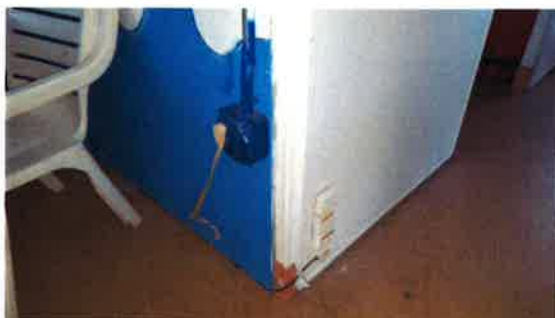
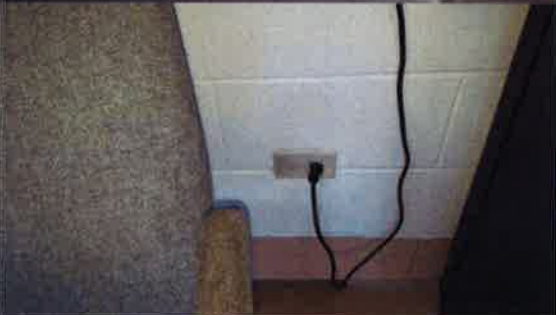
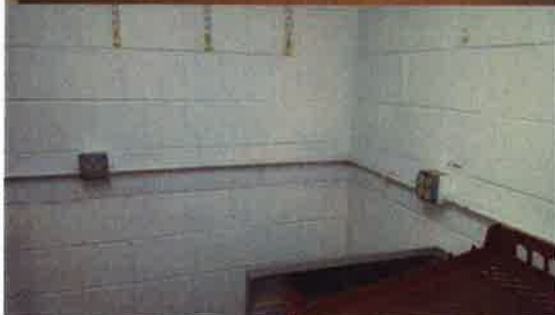
There are a combination of 15 amp and 20 amp rated receptacles present with GFCI type located at sinks. There are some extension cords present.

The receptacles are in average condition with some receptacles showing over-paint on them. Faceplates are in average to poor condition.

Replace receptacles and faceplates as required.

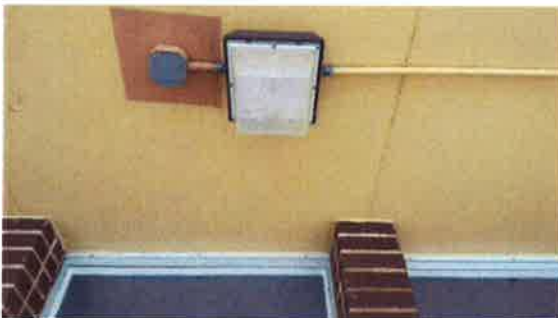
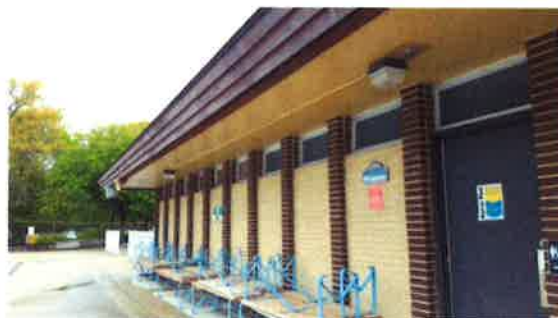
Exterior building lighting consists of surface mounted LED square fixtures and recessed 1' x 1' HID square, lensed fixtures. Site lighting consists of HID pole mounted heads mounted on what appears to be round 30'-0" poles.

Exterior building surface mounted lighting is in good condition while the recessed 1' x 1' fixtures are in average condition. Exterior pole mounted light fixtures and poles are in average condition.

Replace the exterior pole mounted lighting fixtures with LED type fixtures that are "Dark Sky Friendly"

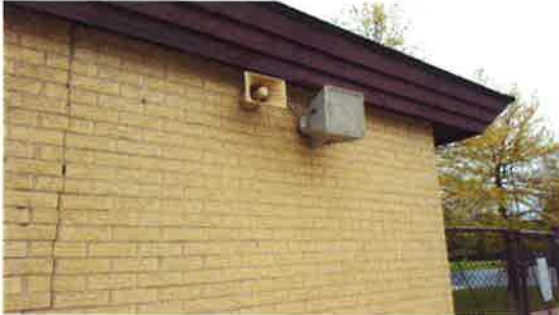
The exterior of the building has a horn system we believe is connected to the Thor Guard system and a music/paging speaker.

The exterior horns and speakers are in average condition.
