## Morton Grove Park District Summary

The following comments are a summary of the Morton Grove Park District's accessibility survey. The survey was begun in the summer of 2013. Each park district facility and buildings used for programs were reviewed for their compliance with the new Americans with Disabilities Act Accessibility Guidelines (ADAAG), Illinois Accessibility Codes (IAC), and the proposed Outdoor Developed Standards. In addition, all elements were evaluated using Equivalent Facilitation standards (ADAAG 103) and Dimensional Tolerances (ADAAG 104.1.1).

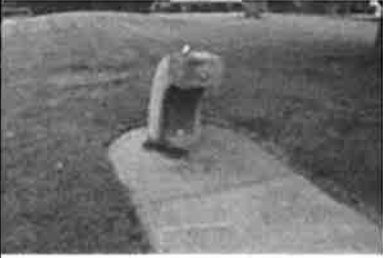
The drinking fountain provided is not of an accessible design.	ADAAG 211 & ADAAG 602	Provide another individual drinking fountain at a standing height or a single hi-lo drinking fountain that provides a wheelchair accessible fountain with a spout at 36" maximum and a standing drinking fountain with a height between 38" minimum and 43" maximum. The toe clearance should be a minimum of 9".	4		\$ 2,125.00

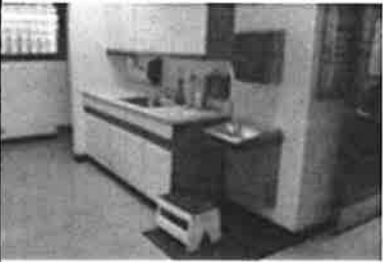
The drinking fountain provides a wheelchair height but not a standing height drinking fountain.	ADAAG 211 & ADAAG 602	Provide another individual drinking fountain at a standing height or a single hi-lo drinking fountain that provides a wheelchair accessible fountain with a spout at 36" maximum and a standing drinking fountain with a height between 38" minimum and 43" maximum. The toe clearance should be a minimum of 9".	<b>4</b>		\$ 2,125.00

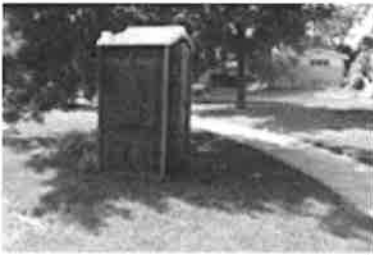
The portable toilet is not of an accessible design and is not on an accessible route.	ADAAG 213.2	For portable toilets, provide at least 5% but no less than one be of an accessible portable toilet design on an accessible route and designed with the International Symbol of Accessibility. When the company delivers a portable toilet make sure they locate them on an accessible route.	<b>3</b>		<b>N/A</b>

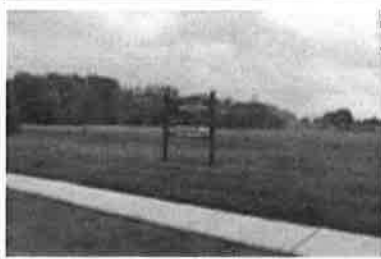
There is no accessible route to the soccer viewing areas at the main field for 142'.	ADAAG 403	Provide a new accessible route with a running slope no steeper than 5% and a cross slope no steeper than 2% and a minimum clear width of 36". If this route is changed for care of the grass, consider using a Mobi Mat or similar beach accessible surface.	2		\$ 4,825.00

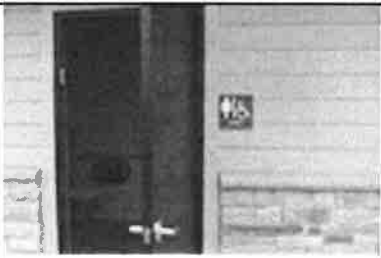
The women's restroom sign is mounted on the hinge side of the door.	ADAAG 216.2	The permanent room sign should to be mounted on the wall at the latch side of the door at 48" minimum from the baseline of the lowest tactile character to 60" maximum from the baseline of the highest character with raised lettering and numbers plus Braille.	4		\$ 150.00

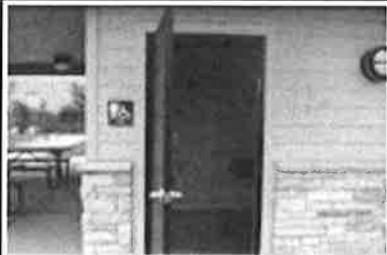
The men's restroom sign is mounted on the hinge side of the door.	ADAAG 216.2	The permanent room sign should to be mounted on the wall at the latch side of the door at 48" minimum from the baseline of the lowest tactile character to 60" maximum from the baseline of the highest character with raised lettering and numbers plus Braille.	<b>4</b>		\$ 150.00

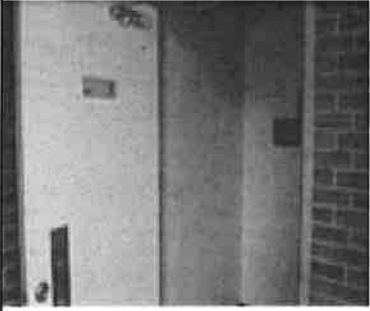
The men's restroom at the pavilion sign is mounted on the door and is not of an accessible design.	ADAAG 216.2	The permanent room sign should to be mounted on the wall at the latch side of the door at 48" minimum from the baseline of the lowest tactile character to 60" maximum from the baseline of the highest character with raised lettering and numbers plus Braille.	4		\$ 150.00

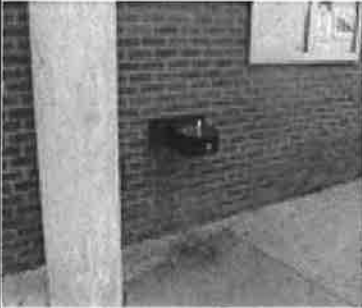
The drinking fountain at the pavilion is mounted too low at 26 1/2" knee clearance and does not provide a standing drinking fountain.	ADAAG 211 & ADAAG 602	Provide two individual drinking fountain or a single hi-lo drinking fountain that provides a wheelchair accessible fountain with a spout at 36" maximum and a standing drinking fountain with a height between 38" minimum and 43" maximum. The toe clearance should be a minimum of 9". The water flow should be at least 4" high and located within 5" from the front of the drinking fountain.	4		\$ 4,350.00

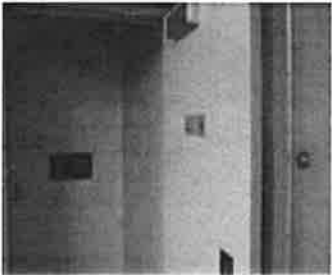
The women's restroom at the pavilion sign is mounted on the door and is not of an accessible design.	ADAAG 216.2	The permanent room sign should to be mounted on the wall at the latch side of the door at 48" minimum from the baseline of the lowest tactile character to 60" maximum from the baseline of the highest character with raised lettering and numbers plus Braille.	4		\$ 150.00

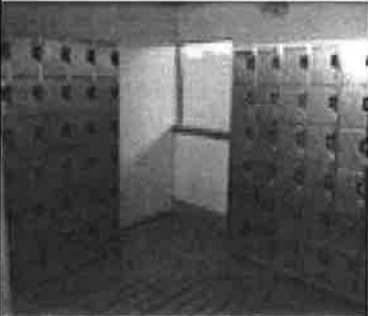
The women's locker room does not provide benches as the lockers.	ADAAG 222 & 903	Provide a bench that is a minimum 42" long, and a minimum of 20" to a maximum of 24" deep. The bench should be affixed to a wall or have a back support that extends at least 42" the length of the bench at a point a maximum of 2" above the seat. The accessible bench should be adjacent to the accessible lockers and have a seat between 17" to 19" AFF.	2		\$ 700.00

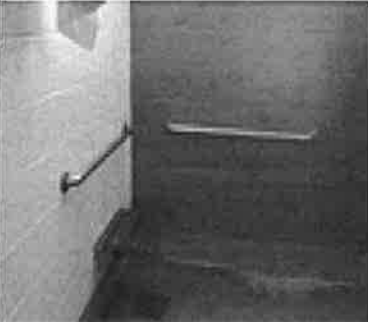
The women's locker room changing area seat is too high at 17 1/2" AFF.	ADAAG 222 & 903	Provide a bench that is a minimum 42" long, and a minimum of 20" to a maximum of 24" deep. The bench should be affixed to a wall or have a back support that extends at least 42" the length of the bench at a point a maximum of 2" above the seat. The accessible bench should be adjacent to the accessible lockers and have a seat between 17" to 19" AFF.	2		\$ 700.00

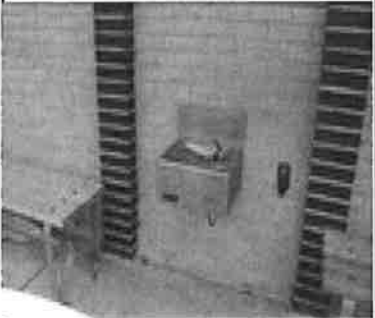
The east drinking fountain is not of an accessible design.	ADAAG 211 & ADAAG 602	Provide two individual drinking fountain or a single hi-lo drinking fountain that provides a wheelchair accessible fountain with a spout at 36" maximum and a standing drinking fountain with a height between 38" minimum and 43" maximum. The toe clearance should be a minimum of 9". The water flow should be at least 4" high and located within 5" from the front of the drinking fountain.	4		\$ 4,350.00

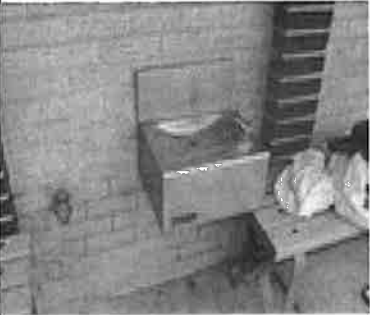
The west drinking fountain is not of an accessible design.	ADAAG 211 & ADAAG 602	Provide two individual drinking fountain or a single hi-lo drinking fountain that provides a wheelchair accessible fountain with a spout at 36" maximum and a standing drinking fountain with a height between 38" minimum and 43" maximum. The toe clearance should be a minimum of 9". The water flow should be at least 4" high and located within 5" from the front of the drinking fountain.	4		\$ 4,350.00

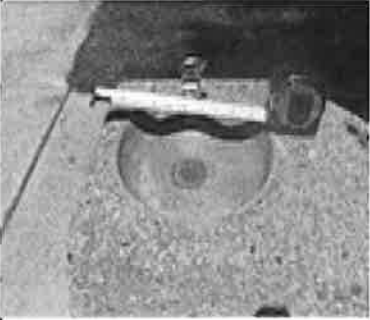
The drinking fountain at the playground has a spout too far back at 6 1/2".	ADAAG 211 & ADAAG 602	Provide two individual drinking fountain or a single hi-lo drinking fountain that provides a wheelchair accessible fountain with a spout at 36" maximum and a standing drinking fountain with a height between 38" minimum and 43" maximum. The toe clearance should be a minimum of 9". The water flow should be at least 4" high and located within 5" from the front of the drinking fountain.	4		\$ 4,350.00

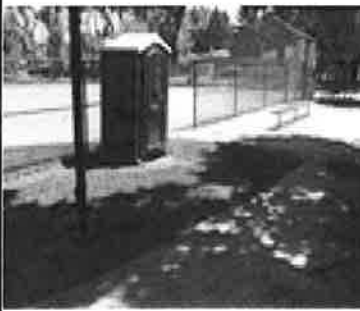
The portable toilet provided is not of an accessible design and not on an accessible route for 8'.	ADAAG 213.2	For portable toilets, provide at least 5% but no less than one be of an accessible portable toilet design on an accessible route and designed with the International Symbol of Accessibility. When the company delivers a portable toilet make sure they locate them on an accessible route.	3		N/A

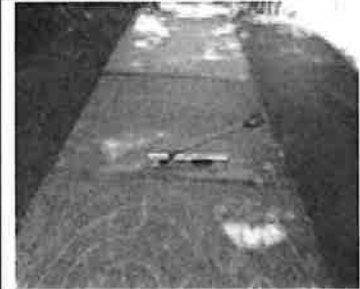
The east entrance walkway between the homes has a cross slope too steep at 2.6% - 3.0% and abrupt transitions of 3/4" for this section of sidewalk. .	ADAAG 403.3	Attempt a "mud jacking" technique or remove and regrade section to provide a cross slope no greater than 2%.	1		\$ 280.00

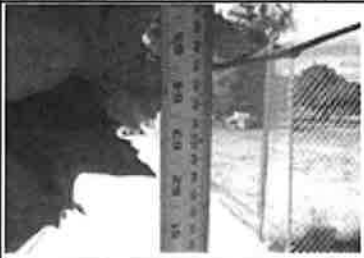
The branches behind ball field #3 protrudes at 64" to 79" AFF.	ADAAG 307	Trim the branch to provide an 80" minimum clear head space and back to the edge of the walkway.	1		\$ 50.00

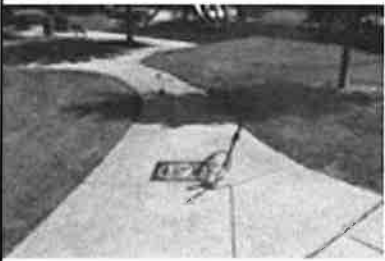
The walkway at the south entrance to the park has a running slope too steep at 5.6% - 8.1% for 18'.	ADAAG 403.3	Remove and regrade section to provide an accessible route with a running slope no greater than 5% and an cross slope no greater than 2%. <b>Option:</b> Since this area is equal to a ramp slope, adding only handrails on both sides would be acceptable. See ADAAG 405.8.	1		\$ 1,100.00

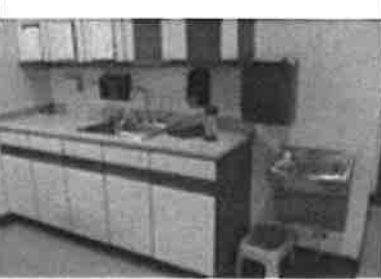
The drinking fountain does not provide a standing height drinking fountain.	ADAAG 211 & ADAAG 602	Provide another individual drinking fountain at a standing height or a single hi-lo drinking fountain that provides a wheelchair accessible fountain with a spout at 36" maximum and a standing drinking fountain with a height between 38" minimum and 43" maximum. The toe clearance should be a minimum of 9".	4		\$ 2,125.00

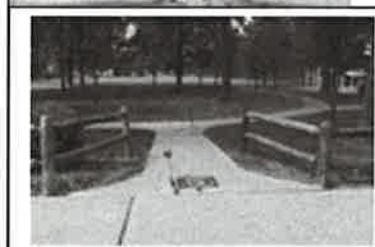
The south east walkway entrance to the park has a running slope too steep at 5.6% - 10.8% for 20'.	ADAAG 403.3	If possible, remove and regrade section to provide a running slope no greater than 5% and a cross slope no greater than 2% for 33'. Because of the slope in this area regrading to 5% may not be possible. Follow ADAAG 405 for ramps if necessary.	1		\$ 2,000.00

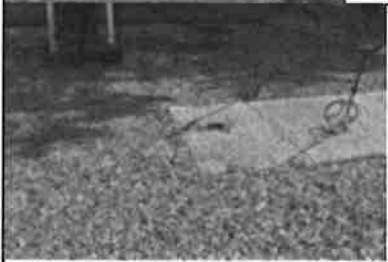
The west playground entrance has a drop off of 1".	ADAAG 1008.2	Extend or provide a new curb ramp from the accessible walkway to the playground surface with a running slope no steeper than 8.3% and an cross slope no steeper than 2%. <b>Option:</b> Provide some additional playground surface material that eliminates the abrupt transition.	<b>2</b>		\$ 1,225.00

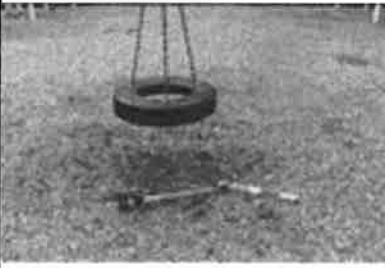
The tire swing surface slope is too high at 20.9% and is mounted too high at 27 1/4".	ADAAG 1008.4.2	Provide a regular maintenance to the play surface to provide an accessible route and cross slopes no greater than 2% in all directions for easier transfer to the tire swing. Provide a tire swing no higher than 24" above the playground surface. <b>UD</b> - Consider a mat under the tire swing to prevent a kick-out of the surface material.	2		\$ 100.00

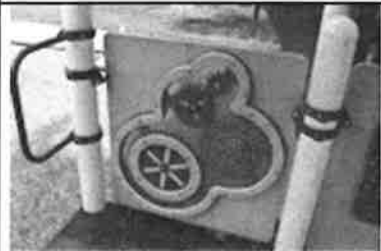
The gear panel provides only finger holes for operation.	ADAAG 309	Provide play features with operable parts that do not require tight grasping, pinching or twisting of the wrist. Some type of handle should be connected to this play panel.	2		\$ 100.00

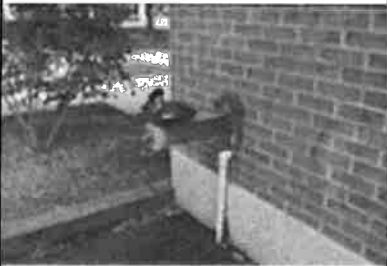
The drinking fountain attached to the building is mounted at 38 1/2" for a standing height but not for a wheelchair height.	ADAAG 211 & ADAAG 602	Provide another individual drinking fountain at a wheelchair height or a single hi-lo drinking fountain that provides a wheelchair accessible fountain with a spout at 36" maximum and a standing drinking fountain with a height between 38" minimum and 43" maximum. The toe clearance should be a minimum of 9".	4		\$ 2,175.00

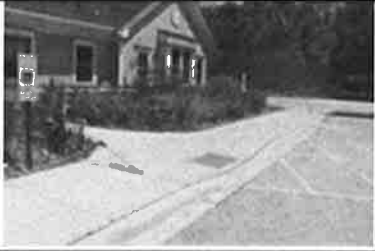
The entry door has an opening force too high at 13 lbs. and closes too quickly at 3 seconds.	IAC 400.310(j)(10)(B)(i)	Adjust the closer so the door opening force is no heavier than 8.5 lbs. to open and takes a minimum of 5 seconds to close or provide an automatic door opener at the door.	1		\$ 100.00

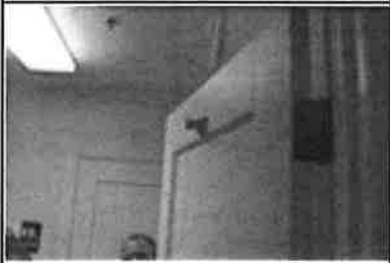
The north restroom coat hook is mounted too high at 80" AFF.	ADAAG 222.1 & ADAAG 308	Provide 5% of the cloths hooks, but not less than one, at a reach range no higher than 48" AFF for a forward reach over an obstruction no deeper than 20" or a side reach of 48" AFF over an object no deeper than 10". Consider adding additional cloths hooks at the lower height.	4		\$ 200.00

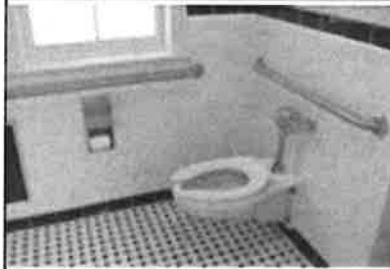
The north restroom toilet paper dispenser is mounted too far from the toilet at 11" in front.	ADAAG 604.7	Remount the toilet paper dispenser to be no lower than 15", no higher than 48" AFF and a centerline of the dispenser that is a minimum of 7" to a maximum of 9" in front of the toilet. Do not mount the toilet paper dispenser behind the side grab bar.	3		\$ 100.00

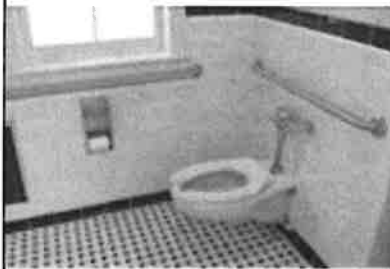
Because of the window frame the side grab bar does not go further into the corner.	ADAAG 604.5.1 & ADAAG 609	Because of the window frame, provide a 12" side grab bar mounted into the corner near the existing side grab bar. Mounting this short grab bar to be 33" to 36" AFF to the top of the grab bar.	3		\$ 155.00

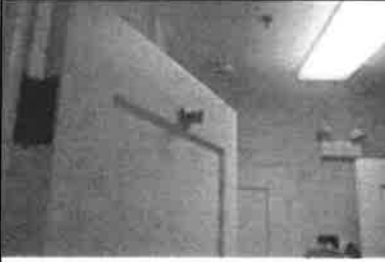
The south restroom coat hook is mounted too high at 80" AFF.	ADAAG 222.1 & ADAAG 308	Provide 5% of the cloths hooks, but not less than one, at a reach range no higher than 48" AFF for a forward reach over an obstruction no deeper than 20" or a side reach of 48" AFF over an object no deeper than 10". Consider adding additional cloths hooks at the lower height.	4		\$ 200.00

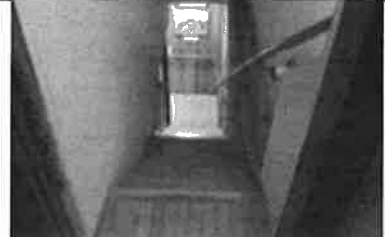
The nosing of the basement steps projects out more than 1" and is not curved. There are 14 steps.	ADAAG 504.5	Provide a curved stair nosing (like a quarter round) under the nosing with a leading edge no greater than 1/2" with a 30 degree maximum angle.	1		\$ 250.00

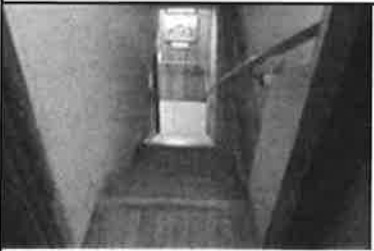
The stairway to the basement has handrails on only one side.	ADAAG 504.6	Provide a second set of handrails that are, continuous on the inside, between 34" to 38" to the top of the railing above the stair nosing, have an outside diameter of between 1 1/4" to 2", have handrails extensions, provide clear space of 1 1/2" and comply with ADAAG 505.	<b>1</b>		\$ 400.00

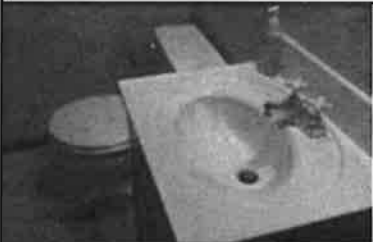
The toilet is mounted too low at 15" AFF.	ADAAG 604.4	Provide a toilet with height at 17" to 19" to the top of the toilet seat.	<b>3</b>		\$ 1,100.00

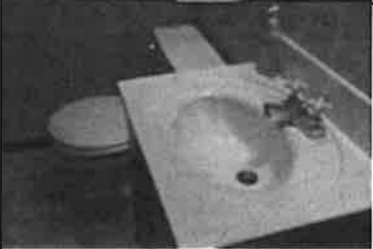
The toilet paper is mounted too far in front of the toilet at 10".	ADAAG 604.7	Remount the toilet paper dispenser to be no lower than 15", no higher than 48" AFF and a centerline of the dispenser that is a minimum of 7" to a maximum of 9" in front of the toilet. Do not mount the toilet paper dispenser behind the side grab bar.	<b>3</b>		\$ 100.00

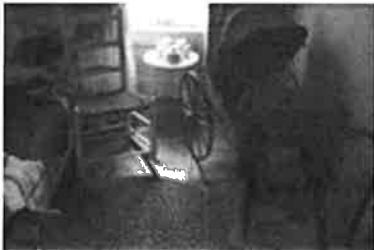
The house especially the 2nd floor is not accessible and many items are blocked from viewing closely.	Everyone's Welcome: The Americans with Disabilities Act and Museums Accessible Facilities and Exhibits	Provide a video of each room, especially the upstairs that a person could view or purchase to see at home. Provide up close views of important historical items that are in the house.	Not required but would be best practices		\$ 300.00

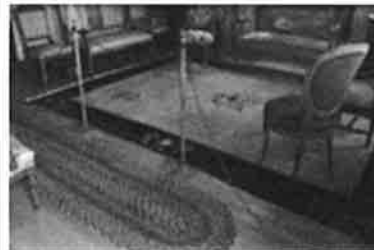
The chain guards are provided but are at varying heights.	Everyone's Welcome: The Americans with Disabilities Act and Museums Accessible Facilities and Exhibits	For chain guards provided, provide ones that hang to at least 27" for a cane detectable barrier, and if possible provide a brighter color for people to see more easily.	Not required but would be best practices		\$ 150.00

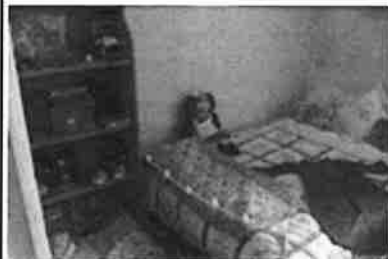
Many of the rooms are chained off and not accessible for a person with a visual impairment to see up close and/or touch.	Everyone's Welcome: The Americans with Disabilities Act and Museums Accessible Facilities and Exhibits	If there are extra items or items that are sturdy, provide a policy and procedure for bringing those items out to people with visual impairments to touch and see up close. This would be beneficial to people with sight as well.			\$ 100.00		
<b>Estimated Total Cost for Accessibility Upgrades for the Museum and Annex</b>						<b>\$ 2,750.00</b>

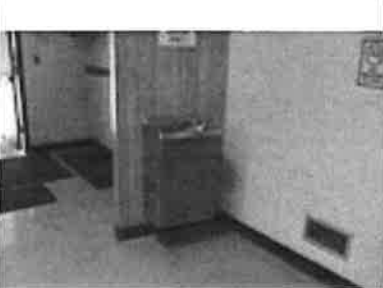
The drinking fountain provides a standing height design but not a wheelchair design.	ADAAG 211 & ADAAG 602	Provide another individual drinking fountain at a wheelchair height or a single hi-lo drinking fountain that provides a wheelchair accessible fountain with a spout at 36" maximum and a standing drinking fountain with a height between 38" minimum and 43" maximum. The toe clearance should be a minimum of 9".	<b>4</b>		\$ 2,175.00

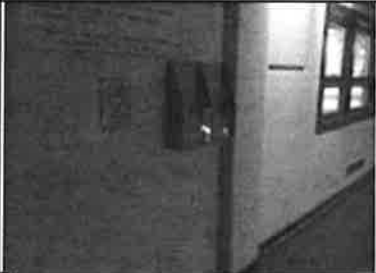
The brochure holder is mounted too high at 52" and 60" AFF.	ADAAG 308	Lower the brochure/flyer holder to be at 48" AFF. <b>UD</b> - Mount all brochure racks no higher than 48" AFF.	<b>4</b>		\$ 100.00

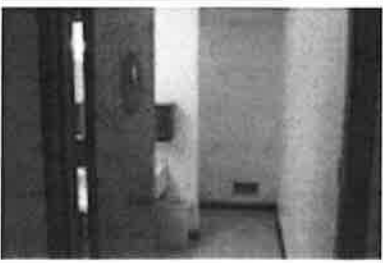
The women's restroom sign is mounted on the door.	ADAAG 216.2	The permanent room sign should to be mounted on the wall at the latch side of the door at 48" minimum from the baseline of the lowest tactile character to 60" maximum from the baseline of the highest character with raised lettering and numbers plus Braille.	<b>4</b>		\$ 150.00

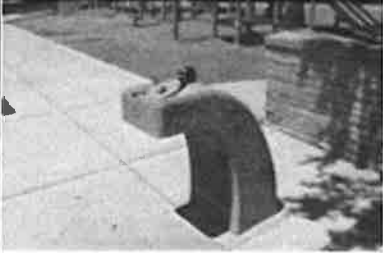
Drinking fountain has a spout located too far from the front at 7".	ADAAG 211 & ADAAG 602	Provide two individual drinking fountain or a single hi-lo drinking fountain that provides a wheelchair accessible fountain with a spout at 36" maximum and a standing drinking fountain with a height between 38" minimum and 43" maximum. The toe clearance should be a minimum of 9". The water flow should be at least 4" high and located within 5" from the front of the drinking fountain.	<b>4</b>		\$ 4,350.00

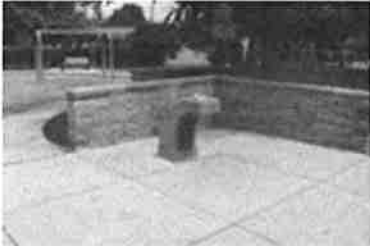
The drinking fountain at the playground area is only of a wheelchair design.	ADAAG 211 & ADAAG 602	Provide another individual drinking fountain at a standing height or a single hi-lo drinking fountain that provides a wheelchair accessible fountain with a spout at 36" maximum and a standing drinking fountain with a height between 38" minimum and 43" maximum. The toe clearance should be a minimum of 9".	<b>4</b>		\$ 2,125.00

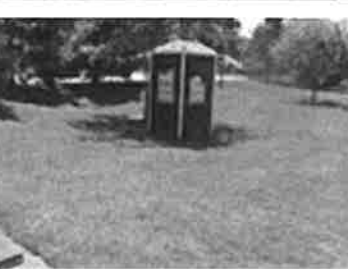
The portable toilet provided was not on an accessible route for 27' and is not of an accessible design.	ADAAG 213.2	For portable toilets, provide at least 5% but no less than one be of an accessible portable toilet design on an accessible route and designed with the International Symbol of Accessibility. When the company delivers a portable toilet make sure they locate them on an accessible route.	3		N/A

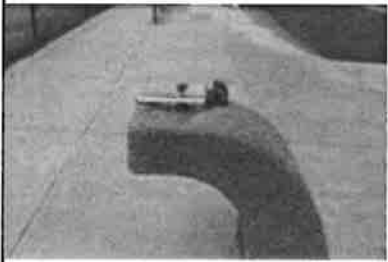
The drinking fountain at the ballfield is not of an accessible design.	ADAAG 211 & ADAAG 602	Provide two individual drinking fountain or a single hi-lo drinking fountain that provides a wheelchair accessible fountain with a spout at 36" maximum and a standing drinking fountain with a height between 38" minimum and 43" maximum. The toe clearance should be a minimum of 9". The water flow should be at least 4" high and located within 5" from the front of the drinking fountain.	4		\$ 4,350.00

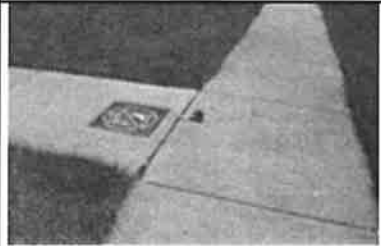
No dog sign painted on sidewalk.	ADAAG 216 & ADAAG 703	Remove stencil and provide a sign that welcomes service animals or add to this stencil making that service animals are welcomed.	4		\$ 155.00

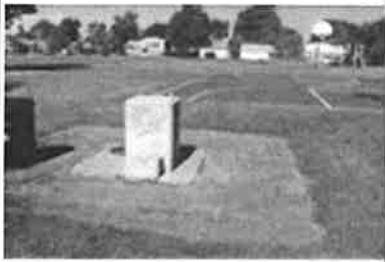
The drinking fountain provides a standing height but not a wheelchair accessible drinking fountain.	ADAAG 211 & ADAAG 602	Provide another individual drinking fountain at a wheelchair height or a single hi-lo drinking fountain that provides a wheelchair accessible fountain with a spout at 36" maximum and a standing drinking fountain with a height between 38" minimum and 43" maximum. The toe clearance should be a minimum of 9".	4		\$ 2,175.00

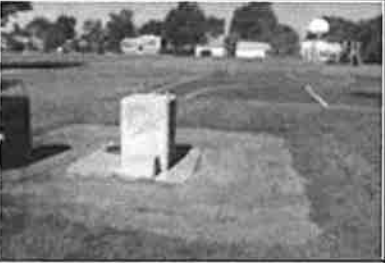
The drinking fountain provided is not on an accessible route for 12'.	ADAAG 403	Provide a new accessible route with a running slope no steeper than 5% and a cross slope no steeper than 2% and a minimum clear width of 36".	4		\$ 400.00

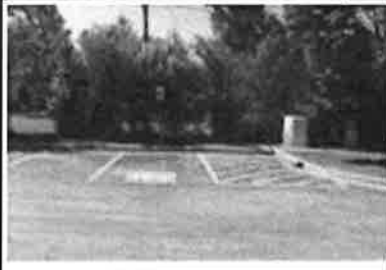
The accessible parking space in the west parking lot has a running slope too steep at 3.1%.	IAC 400.310(c)(7)	Mark out the old striping on the old accessible parking space, restripe the new parking space with an access aisle at least 96" across from the pool entrance with the curb ramp. Also remove and remount the accessible parking space at the head of the new accessible parking space.	1		\$ 360.00		
<b>Estimated Total Cost for Accessibility Upgrades for Oriole Park</b>						<b>\$22,030.00</b>

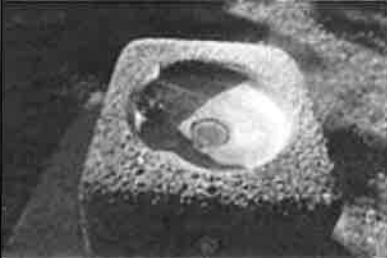
The drinking fountain spout is too far from the front at 7".	ADAAG 211 & ADAAG 602	Provide two individual drinking fountain or a single hi-lo drinking fountain that provides a wheelchair accessible fountain with a spout at 36" maximum and a standing drinking fountain with a height between 38" minimum and 43" maximum. The toe clearance should be a minimum of 9". The water flow should be at least 4" high and located within 5" from the front of the drinking fountain.	4		\$ 4,350.00

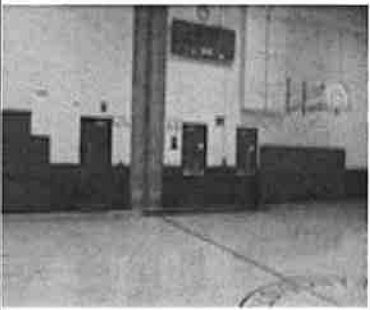
The gym doors have opening forces too high at 7 lbs. the left door, center door 20 lbs. and right door 11 lbs. and close too quickly at left and center doors 3 seconds.	ADAAG 404.2.8 & ADAAG 404.2.9	Adjust the closer so the door opening force is no heavier than 5 lbs. to open and takes a minimum of 5 seconds to close or provide an automatic door opener at the door.	2		\$ 100.00

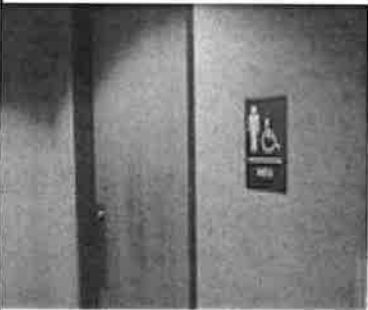
The men's restroom sign is mounted too high at 61" on center and is not on the proper side of the door.	ADAAG 216.2	The permanent room sign should to be mounted on the wall at the latch side of the door at 48" minimum from the baseline of the lowest tactile character to 60" maximum from the baseline of the highest character with raised lettering and numbers plus Braille.	4		\$ 150.00

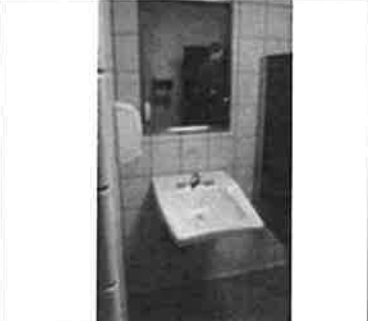
The men's restroom mirror is mounted too high at 45 1/4" AFF.	ADAAG 603.3	Lower the mirror above the sink or countertop to be no higher than 40" to the reflective surface. Mirrors not mounted above the sink or a counter top should be mounted no higher than 35" to the reflective surface. <b>UD</b> - A full-length mirror would be a recommended option.	4		\$ 460.00

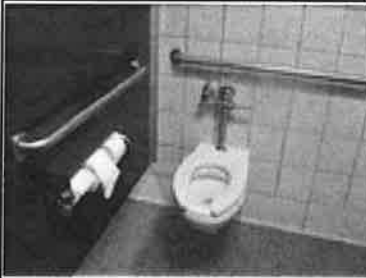
The men's restroom grab bars are not installed correctly with the rear grab bar on the side the side grab bar at the rear plus they are mounted too high at 36 1/2" - 37" AFF.	ADAAG 609.4	Flip flop the grab bars and remount the grab bars to be between 33" to 36" AFF to the top of the grab bars.	3		\$ 100.00

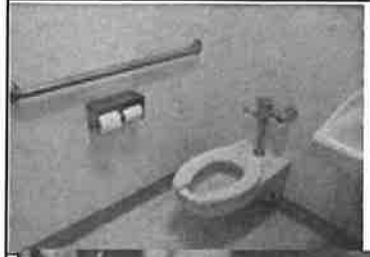
The women's restroom toilet is mounted too far from the wall at 19 1/4" centerline.	ADAAG 604.2	Build out the side wall and grab bar or relocate the toilet to have a centerline 16" to 18" from the wall.	3		\$ 765.00

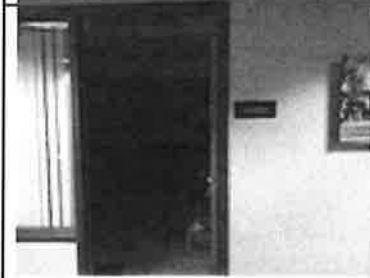
The Kids Center 2-7 year old restroom sign is not of an accessible design and is not mounted correctly.	ADAAG 216.2	The permanent room sign should to be mounted on the wall at the latch side of the door at 48" minimum from the baseline of the lowest tactile character to 60" maximum from the baseline of the highest character with raised lettering and numbers plus	4		\$ 150.00

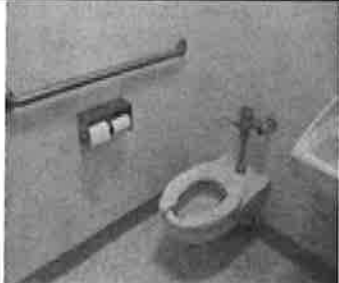
The Kid's Center toilet grab bars are mounted too high and is missing a rear grab bar.	ADAAG 604.5	Depending on the age of children, the children's grab bar at the accessible toilet should be mounted at 18" AFF to 20" AFF for children ages 3 to 4, 20" AFF to 25" AFF for children ages 5 to 8 and 25" to 27" for children ages 9 to 12. The rear grab bar should be a minimum of 36" long and 4" to 6" from the corner and the side grab bar a minimum of 42" long and a maximum of 12" from the corner.	3		\$ 525.00

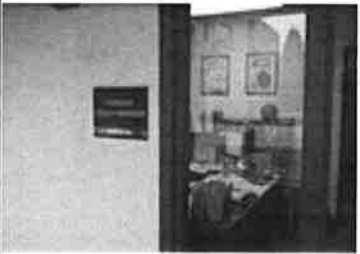
The park police, recreation supervisor and assistant facility manager signs are all mounted too high.	ADAAG 216.2	The permanent room sign should to be mounted on the wall at the latch side of the door at 48" minimum from the baseline of the lowest tactile character to 60" maximum from the baseline of the highest character with raised lettering and numbers plus	4		\$ 300.00

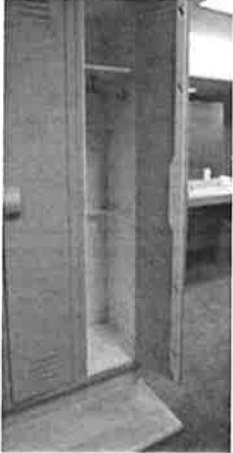
The 47 lockers provided are not of an accessible design.	ADAAG 225.1 & 811	Provide at least 5% of the lockers with the coat hook and shelf no higher than 48" for a side approach or front approach. The base should be no lower than 15" and provide accessible door hardware. A 30" by 48" clear floor space should be provided at the accessible lockers with accessible locker door hardware. Provide these at or near the accessible bench.	2		\$ 750.00

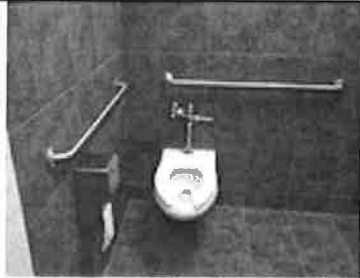
The men's restroom grab bars are not installed correctly with the rear grab bar on the side the side grab bar at the rear.	ADAAG 609.4	Flip flop the grab bars and remount the grab bars to be between 33" to 36" AFF to the top of the grab bars.	3		\$ 100.00

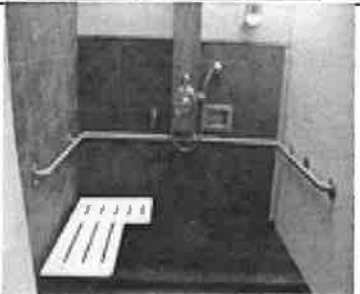
The men's locker room roll in shower seat is mounted too high at 20 1/4" AFF.	ADAAG 610.3	Provide a new shower seat that is mounted 17" to 19" above the bathroom floor and extend the full depth of the shower and be within 3" of the compartment entrance. Blocking within the walls will be necessary for securing the shower seat.	3		\$ 625.00

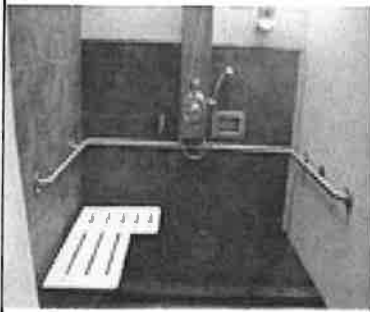
The men's locker room roll in shower grab bars extend behind the seat.	ADAAG 608.3	Provide grab bars that go the around the shower stall as shown in ADAAG Figure 608.3.2 for a roll-in shower or part of the way around for an transfer shower as shown in ADAAG 608.3.1. The grab bars should be mounted between 33" to 36" centerline of the grab bar and must comply with ADAAG 609.	3		\$ 525.00

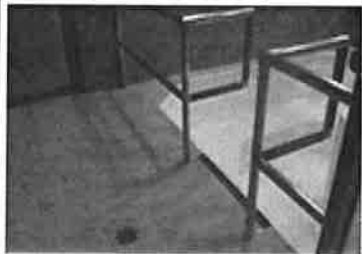
The whirlpool/spa does not provide a transfer system or lift from the walkway into the water.	ADAAG 242.4	Provide an accessible means of entrance into the whirlpool such as a pool lift, transfer wall or transfer system.	2		\$ 4,250.00

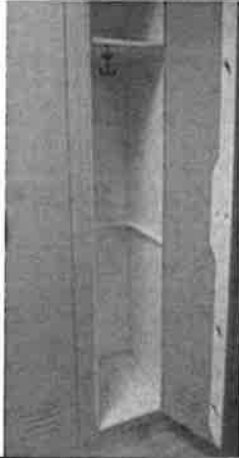
The 26 lockers provided are not of an accessible design.	ADAAG 225.1 & 811	Provide at least 5% of the lockers with the coat hook and shelf no higher than 48" for a side approach or front approach. The base should be no lower than 15" and provide accessible door hardware. A 30" by 48" clear floor space should be provided at the accessible lockers with accessible locker door hardware. Provide these at or near the accessible bench.	2		\$ 500.00

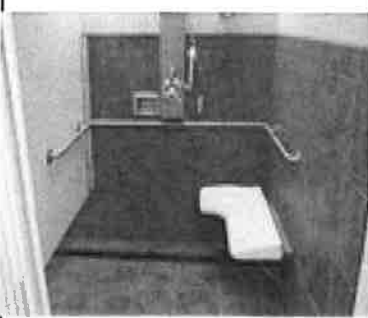
The women's locker room roll in shower grab bars extend behind the seat.	ADAAG 608.3	Provide grab bars that go the around the shower stall as shown in ADAAG Figure 608.3.2 for a roll-in shower or part of the way around for an transfer shower as shown in ADAAG 608.3.1. The grab bars should be mounted between 33" to 36" centerline of the grab bar and must comply with ADAAG 609.	3		\$ 525.00

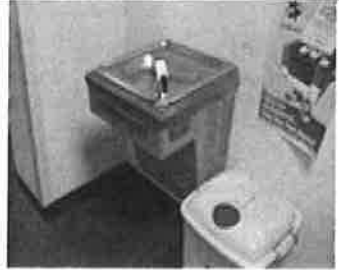
The drinking fountain is a wheelchair drinking fountain mounted at a standing height drinking fountain.	ADAAG 211 & ADAAG 602	Provide another individual drinking fountain at a wheelchair height or a single hi-lo drinking fountain that provides a wheelchair accessible fountain with a spout at 36" maximum and a standing drinking fountain with a height between 38" minimum and 43" maximum. The toe clearance should be a minimum of 9".	4		\$ 2,175.00

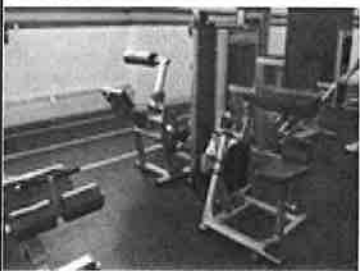
The back, arm curl, lateral raise, Precor bike, elliptical and tread mill machines do not provide the clear floor space of 30" by 48" for at least one each type of the machines.	ADAAG 1004	Relocated or reconfigure these and the adjacent machines to provide a minimum 30" by 48" clear floor space.	2		\$ 500.00

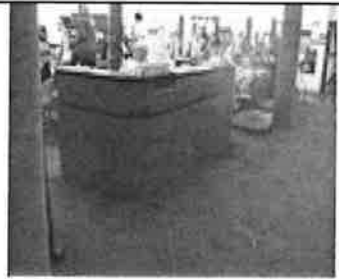
The counter in the fitness area is too high at 44" AFF.	IAC 400.320(h)(1) (A)	Provide a section of counter that is no higher than 34" and is at least 36" long. In alterations where it is technically infeasible to provide an accessible counter, an auxiliary counter meeting those requirements may be provided.	2		\$ 625.00

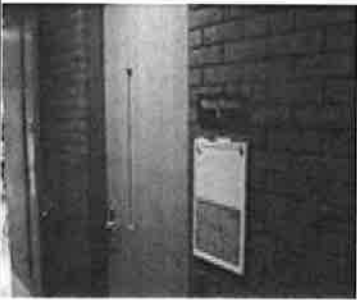
The Music Room A and B sign is not of an accessible design and is in the wrong location.	ADAAG 216.2	The permanent room sign should to be mounted on the wall at the latch side of the door at 48" minimum from the baseline of the lowest tactile character to 60" maximum from the baseline of the highest character with raised lettering and numbers plus Braille.	4		\$ 150.00

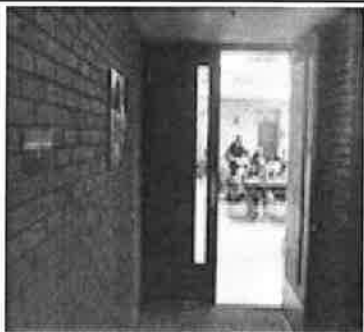
The Community Room sign is not of an accessible design.	ADAAG 216.2	The permanent room sign should to be mounted on the wall near the doors when they are open at 48" minimum from the baseline of the lowest tactile character to 60" maximum from the baseline of the highest character with raised lettering and numbers plus Braille.	4		\$ 150.00

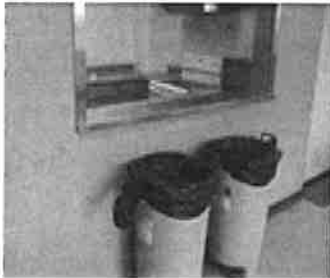
The counter mounted too high.	IAC 400.320(h)(1)(A)	Provide a section of counter that is no higher than 34" and is at least 36" long. In alterations where it is technically infeasible to provide an accessible counter, an auxiliary counter meeting those requirements maybe provided.	2		\$ 625.00

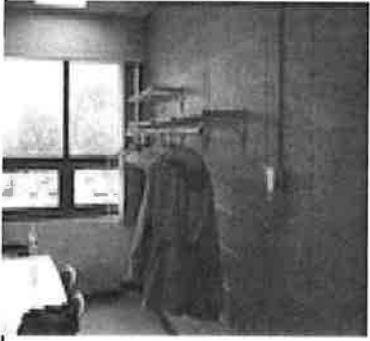
The wall mounted coat hangers provided are mounted too high at 56" AFF.	ADAAG 222.1 & ADAAG 308	Provide 5% of the cloths hooks, but not less than one, at a reach range no higher than 48" AFF for a forward reach over an obstruction no deeper than 20" or a side reach of 48" AFF over an object no deeper than 10". Consider adding additional cloths hooks at the lower height.	4		\$ 200.00

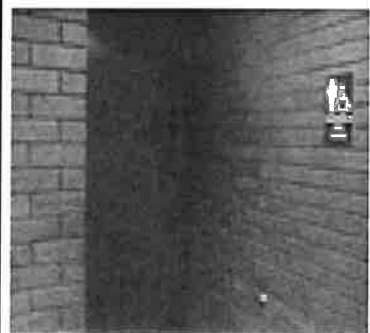
The men's restroom sign is mounted too high at 69" to center AFF.	ADAAG 216.2	The permanent room sign should to be mounted on the wall at the latch side facing out from the door at 48" minimum from the baseline of the lowest tactile character to 60" maximum from the baseline of the highest character with raised lettering and numbers plus Braille.	4		\$ 150.00

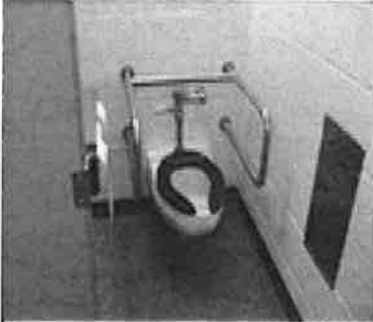
The women's restroom stall is too narrow and does not provide proper grab bars.	ADAAG 604	Provide an accessible stall that is a minimum of 60" wide and a minimum of 56" deep with a minimum 42" side grab bar mounted 12" maximum from the corner and a 36" rear grab bar mounted 12" minimum from the centerline and 24" from the centerline to the transfer side of the toilet. The toilet centerline should be 16" to 18" from the nearest wall and a minimum 17" to a maximum 19" to the top of the seat. This will require remove of the adjacent toilet and taking over that space. Check plumbing codes to determine if this is acceptable related to the fixture count.	3		\$ 3,575.00

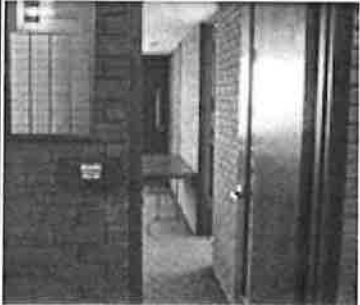
The Board Room, Resource Center Human Resource Generalist, Finance Coordinator, Marketing and Information Manager, Employee Room, Facility and Recreation Manager, Recreation Supervisor, Work Room, Liponi Foundation Liaison, Business Manager and Board Room have signs that are not mounted at the proper heights. The Public Information Manager sign also requires Braille.	ADAAG 216.2	The permanent room sign should to be mounted on the wall at the latch side of the door at 48" minimum from the baseline of the lowest tactile character to 60" maximum from the baseline of the highest character with raised lettering and numbers plus Braille.	4		\$ 450.00

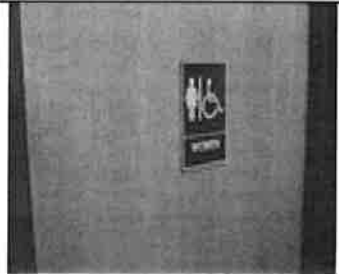
The women's restroom sign is mounted on the door.	ADAAG 216.2	The permanent room sign should to be mounted on the wall at the latch side of the door at 48" minimum from the baseline of the lowest tactile character to 60" maximum from the baseline of the highest character with raised lettering and numbers plus Braille.	4		\$ 150.00

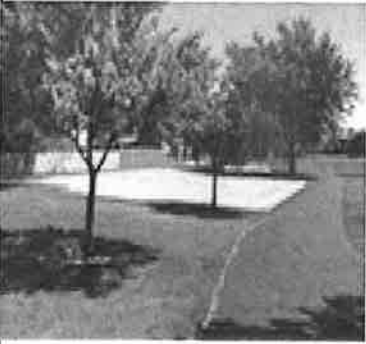
This small parking lot does not provide accessible parking.	IAC 400.310(c)	If used, provide one accessible parking space with an access aisle a minimum of 96" plus a sign with the International Symbol of Accessibility and a fine sign of \$250 to \$350 (Depending on local code) at the head of the parking space. The parking space and access aisle should be no steeper than 2% in all directions and on a firm and stable surface. Locate the accessible parking space on the shortest accessible route. <b>UD</b> - Provide a Universally Designed parking space with a minimum 11' (132") parking space and a minimum 5' (60") access aisle.	1		\$ 775.00

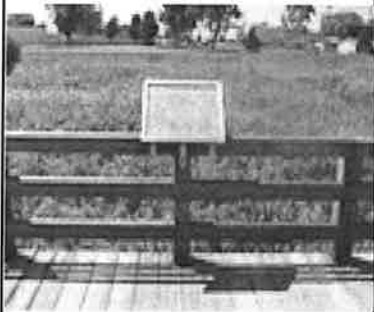
The nature preserve sign is not of an accessible design and is mounted at 26" - 49 1/2" AFF.	Everyone's Welcome: The Americans with Disabilities Act and Museums - Accessible Facilities and Exhibits	<b>Signage Recommendation:</b> Provide an accessible typeface such as Helvetica, Arial, Univers or Futura for Sans Serif or New Century Schoolbook, Times Roman or Palatine which is Simple Serif. Provide a type face that is at least 18 points or larger and is provided on a contrasting background of at least 70% and not written over a picture. The signage should be mounted at above the floor at a centerline of 54" AFF. For signage mount them between 33" to 40" AFF and angle them at a 40 degree to 45 degree angle.	2		\$ 160.00

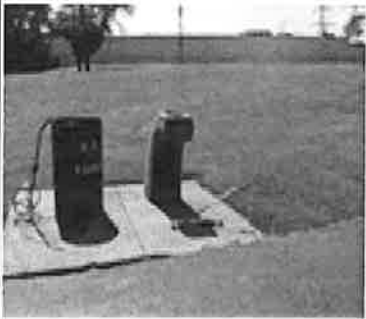
The drinking fountain has a spout too far back at 6 1/2".	ADAAG 211 & ADAAG 602	Provide two individual drinking fountain or a single hi-lo drinking fountain that provides a wheelchair accessible fountain with a spout at 36" maximum and a standing drinking fountain with a height between 38" minimum and 43" maximum. The toe clearance should be a minimum of 9". The water flow should be at least 4" high and located within 5" from the front of the drinking fountain.	4		\$ 4,350.00

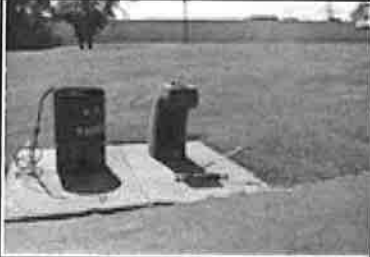
The walkway in front of the drinking fountain has a cross slope too steep at 4.0%.	ADAAG 305	At the drinking fountain, remove and repour concrete to provide a clear floor space of at least 30" wide by 48" deep that is connected by an accessible route. The clear floor space should have a slope no steeper than 2% in all	2		\$ 250.00

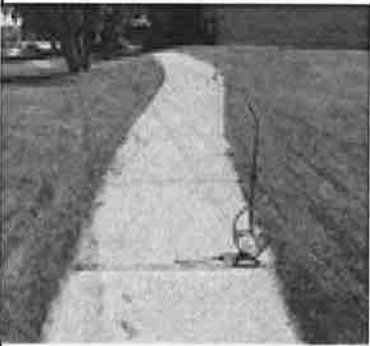
The south walkway north of the tree and south of the north ballfield has a running slope too steep at 5.6% - 8.4% for 25'.	ADAAG 403.3	Remove and regrade section to provide an accessible route with a running slope no greater than 5% and an cross slope no greater than 2% for 36'. <b>Option:</b> Since this area is equal to a ramp slope, adding only handrails on both sides would be acceptable. See ADAAG 405.8.	1		\$ 2,200.00

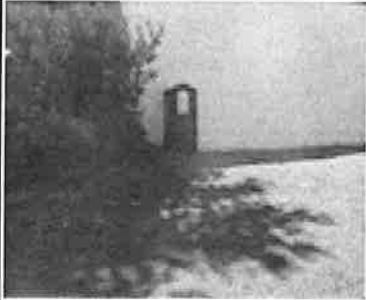
The portable toilet provided is not on an accessible route and is not of an accessible design.	ADAAG 213.2	For portable toilets, provide at least 5% but no less than one be of an accessible portable toilet design on an accessible route and designed with the International Symbol of Accessibility. When the company delivers a portable toilet make sure they locate them on an accessible route.	3		N/A

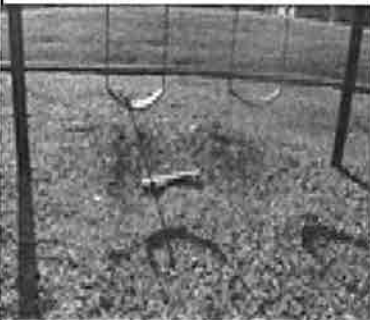
The swing surface slope is too steep at 16.6% - 18.7% and seat heights too high at 26 1/2" and 28 3/4".	ADAAG 1008.4.2	Provide a regular maintenance to the play surface to provide an accessible route and cross slopes no greater than 2% in all directions for easier transfer to the swing. Provide swings no higher than 24" above the playground surface. An accessible swing with a seat would be recommended at some point. <b>UD</b> - Consider a mat under the swings to prevent a kick-out of the surface material.	2		\$ 100.00

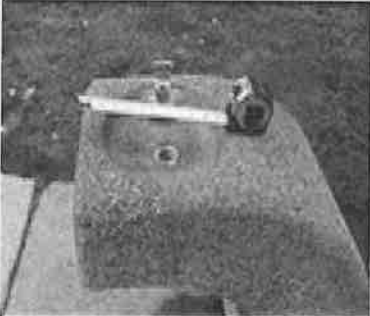
The drinking fountain has a spout too far back at 7"..	ADAAG 211 & ADAAG 602	Provide two individual drinking fountain or a single hi-lo drinking fountain that provides a wheelchair accessible fountain with a spout at 36" maximum and a standing drinking fountain with a height between 38" minimum and 43" maximum. The toe clearance should be a minimum of 9". The water flow should be at least 4" high and located within 5" from the front of the drinking fountain.	4		\$ 4,350.00

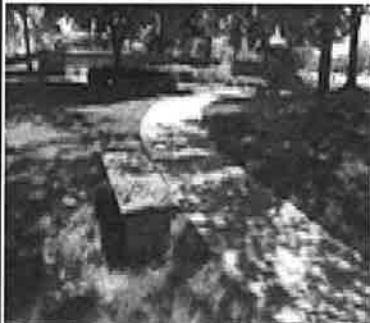
There are two benches provided but neither provided companion seating.	<u>Proposed</u> Outdoor Areas Standards ADAAG 1011	<b>Bench Recommendation:</b> Provide at least 20% but no less than two benches to provide a clear ground space of at least 30" by 48" positioned near the bench with one side adjoining the walkway. The clear ground space should have a slope no steeper than 2% in all directions. The clear ground space should not overlap the accessible route or another clear ground space. <b>UD -</b> Provide benches with armrests, backs, seat height between 17" AFF to 19" AFF maximum and no gaps between the seat and backrest.	<b>2</b>		\$ 2,000.00

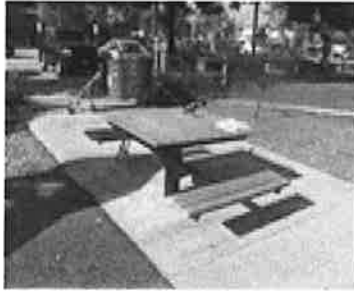
The picnic table provided at the playground entrance is not of an accessible design with knee clearance too low at 24" AFF.	<u>Proposed</u> Outdoor Developed Areas Guidelines ADAAG 245 & 1011	<b>Picnic Table Recommendation:</b> At least 20% of picnic tables, but no less than two, be of an accessible design, connected to an accessible route. Relocate or purchase two accessible picnic tables (\$750/each) and locate them on an accessible surface (\$900).	2		\$ 3,300.00

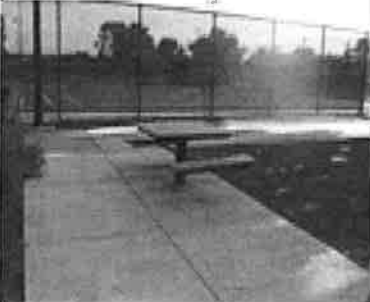
The picnic table provided at the tennis courts entrance is not of an accessible design with knee clearance too low at 25 1/2" AFF.	<u>Proposed</u> Outdoor Developed Areas Guidelines ADAAG 245 & 1011	<b>Picnic Table Recommendation:</b> At least 20% of picnic tables, but no less than two, be of an accessible design, connected to an accessible route. Relocate or purchase two accessible picnic tables (\$750/each) and locate them on an accessible surface (\$900).	2		\$ 3,300.00

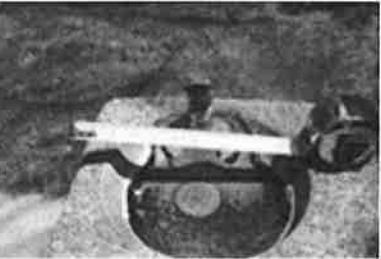
The drinking fountain has a spout too far from the front at 6 1/4".	ADAAG 211 & ADAAG 602	Provide two individual drinking fountain or a single hi-lo drinking fountain that provides a wheelchair accessible fountain with a spout at 36" maximum and a standing drinking fountain with a height between 38" minimum and 43" maximum. The toe clearance should be a minimum of 9". The water flow should be at least 4" high and located within 5" from the front of the drinking fountain.	4		\$ 4,350.00

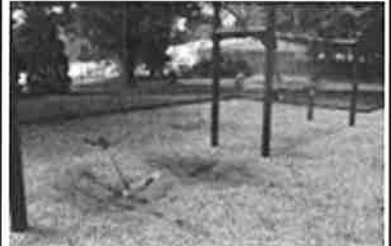
The swing surface slope is too steep at 14.5% - 19.6% and are too high at 26" and 26 1/2".	ADAAG 1008.4.2	Provide a regular maintenance to the play surface to provide an accessible route and cross slopes no greater than 2% in all directions for easier transfer to the swing. Provide swings no higher than 24" above the playground surface. An accessible swing with a seat would be recommended at some point. <b>UD</b> - Consider a mat under the swings to prevent a kick-out of the surface material.	2		\$ 100.00

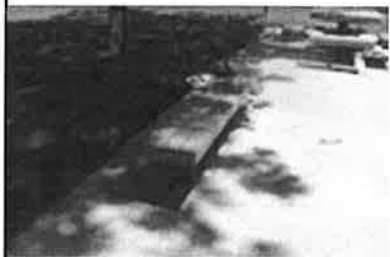
There is only one bench provided.	<u>Proposed</u> Outdoor Areas Standards ADAAG 1011	<b>Bench Recommendation:</b> Provide at least 20% but no less than two benches to provide a clear ground space of at least 30" by 48" positioned near the bench with one side adjoining the walkway. The clear ground space should have a slope no steeper than 2% in all directions. The clear ground space should not overlap the accessible route or another clear ground space. <b>UD</b> - Provide benches with armrests, backs, seat height between 17" AFF to 19" AFF maximum and no gaps between the seat and backrest.	Not approved but considered best practices		\$ 2,000.00

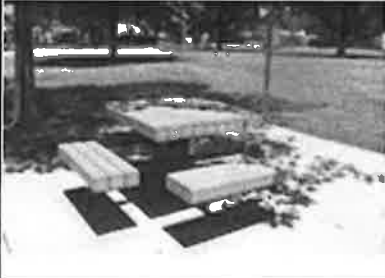
There are two picnic tables provided but neither are of an accessible design and one is not on an accessible route.	<u>Proposed</u> Outdoor Developed Areas Guidelines ADAAG 245 & 1011	<b>Picnic Table Recommendation:</b> At least 20% of picnic tables, but no less than two, be of an accessible design, connected to an accessible route. Relocate or purchase two accessible picnic tables (\$750/each) and locate them on an accessible surface (\$900).	Not approved but considered best practices		\$ 3,300.00

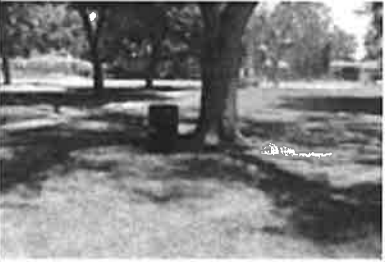
Another trash can is located off the accessible route for 11'.	<u>Proposed</u> Outdoor Developed Areas Guidelines 1011	<b>Trash Can Recommendation:</b> Locate trash cans on an accessible route as part of your regular policy. For a forward approach provide a trash can within 24" and a minimum clear ground space of 36" by 48" or for a side approach provide a trash can within 24" and a minimum clear ground space of 30" by 60".	Not approved but considered best practices		\$ 50.00	↑
